# Historic Building Conditions Assessment Report

Abbott/Laurel Schoolhouse  
7 Shepard Street, Milford, NH

May 2023

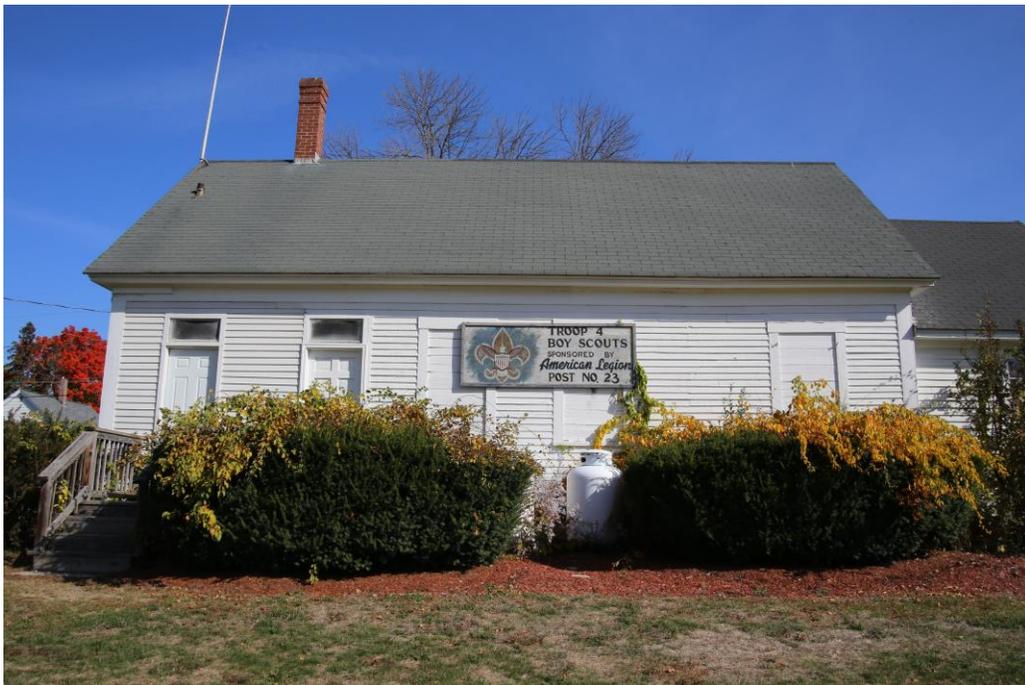
*Photo 29: South elevation showing roof, closed window openings, and vegetation growing close to the exterior wall.*

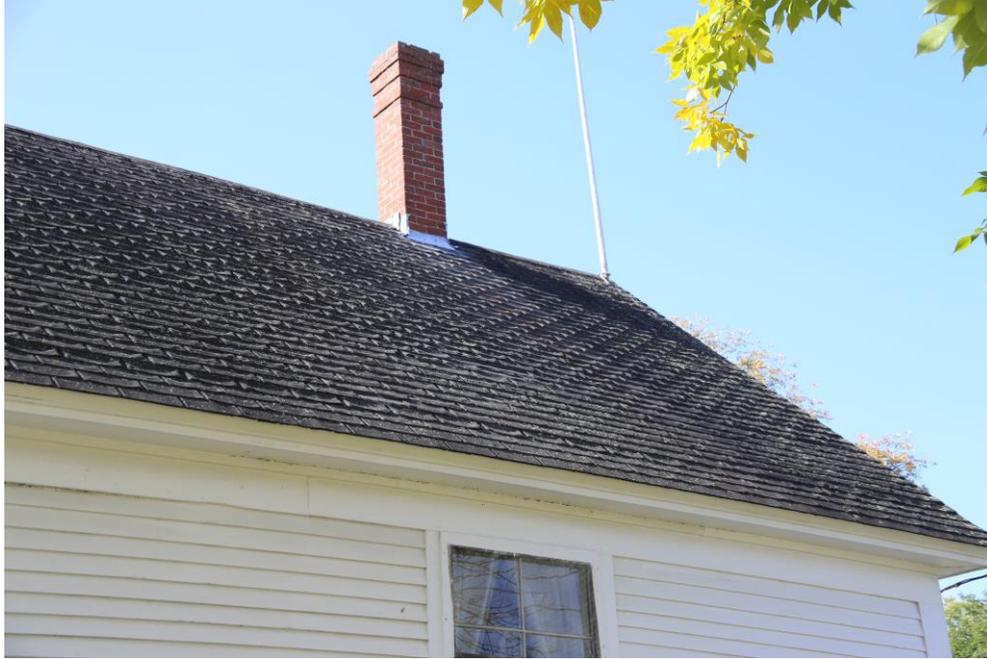
*Photo 30: North elevation roof, showing degradation and curling of the asphalt shingles.*

The roof is covered in three-tab asphalt shingles. The south slope has been installed more recently than the north and is lighter in color. The asphalt shingles on the north slope have reached their useable life and are visibly degrading.

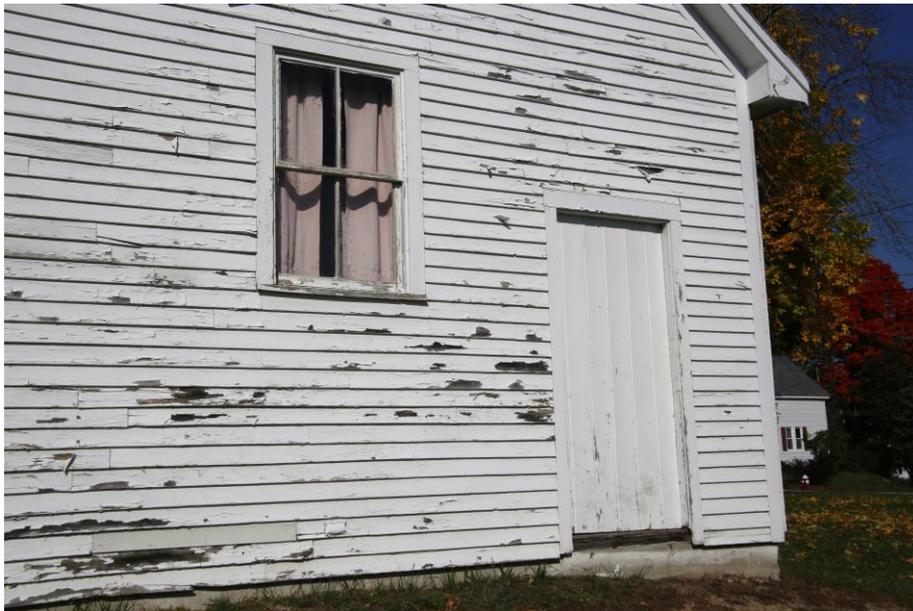
*Photo 31: East elevation, part of the 1980s addition, showing severe loss of paint on the wood trim and clapboards. The 2/2 window is an older window reused in the construction.*

The exterior shows visible signs of rot in clapboards and window sills in several areas. The paint on the clapboards and trim is peeling in thick layers in several areas, most notably on the east

elevation of the addition. The clapboards on the lower areas of the north side are deteriorated and need replacing. The south elevation could not be fully assessed because of the large bushes planted very close to the walls, which will lead to trapped moisture against this wall.

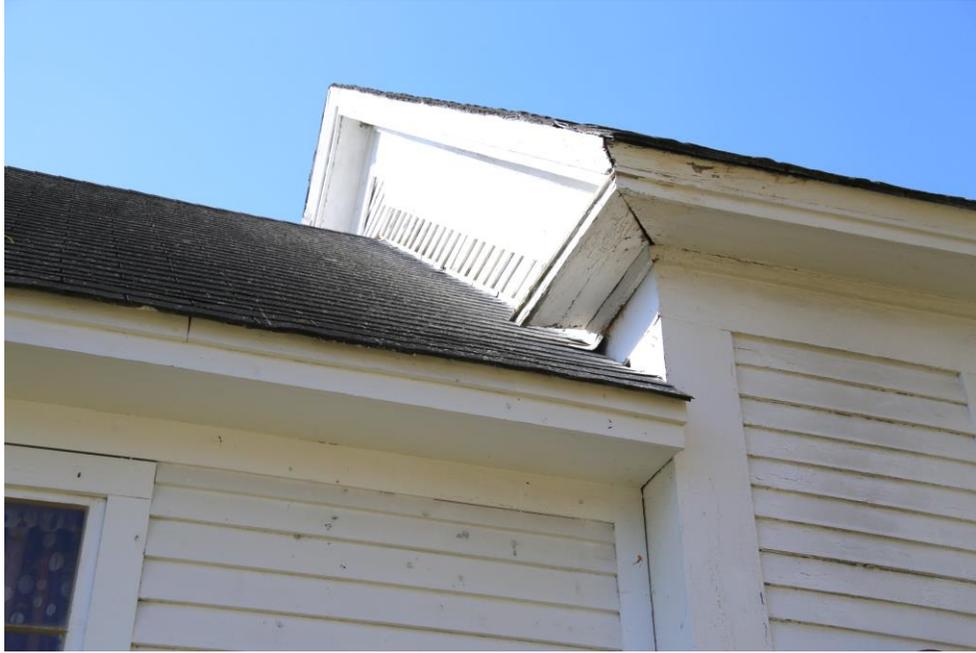
*Photo 32: Cornice return on the northeast corner of the main building shows paint loss and open joints.*

The trim throughout the building is generally in good condition, but several areas on the main building show signs of decay, especially at the cornice and eave lines where paint is peeling and joints are loose or opening.

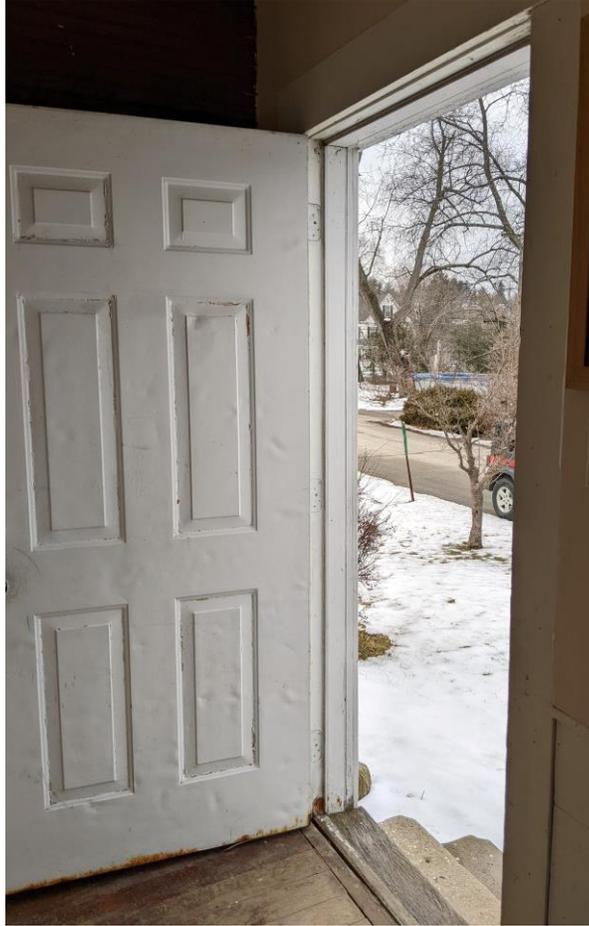
*Photo 37: Front door, showing the dents in the surface and rust forming along the bottom edge (Flynn).*

The front door is a modern replacement metal door with a 6-panel design. It is near the end of its lifespan, as corrosion is showing on the base and it is heavily dented. A new or salvaged wood door, with a similar 6-panel arrangement, would be a more appropriate replacement. The other exterior doors on the south elevation are in better condition. The door to the storage room is a modern fiberglass 6-panel replacement. The non-functional door to the bathroom is a wood, 6-panel door, likely dating to the mid-twentieth century (after ca. 1961, see Figure 10, page 16). Both doors have transoms with wood-framed screens affixed to the exterior. The screens, along with those on the windows, are functional but unsightly as trim paint has spilled over onto them.

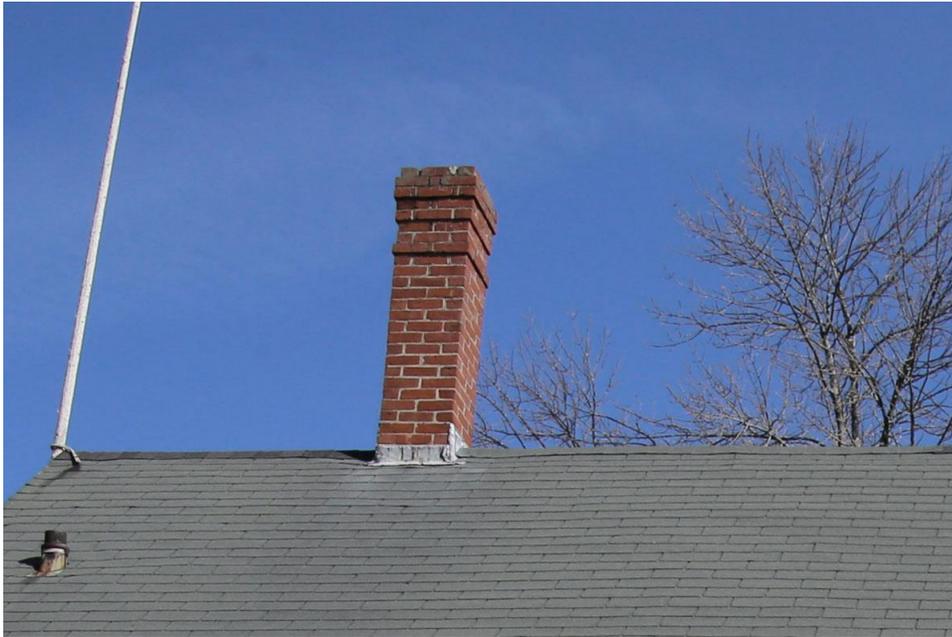
*Photo 38: Brick stove chimney, with a few areas in need of repointing in the top corbeled section.*

The brick stove chimney is no longer in use and is generally in good condition, though uncapped. The exterior shows some need for maintenance and repointing of the topmost courses of bricks.

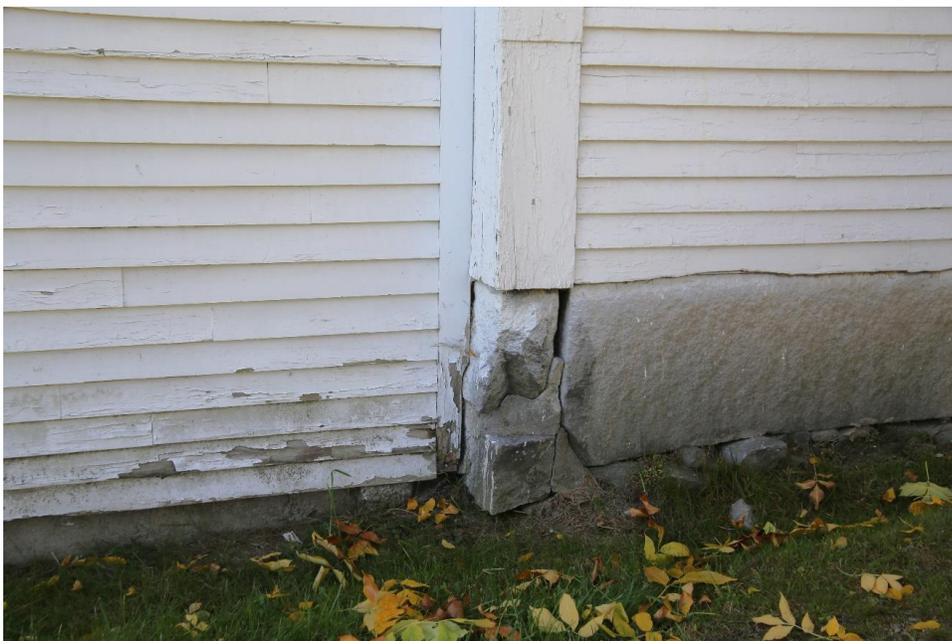
*Photo 39: Northeast corner foundation, showing open joints and loss of mortar. Rot in the lower clapboards at left.*

The foundations of the original building are mortared granite rubble capped with limestone blocks. The exterior exposure of the foundation shows several areas where the mortar has deteriorated, leaving open gaps between stones. The original mortar was most likely lime-based, and modern repointing efforts using Portland Cement have been inadequate. The north side of the building has areas of biogrowth, evidence of moisture retention especially behind a woodpile stacked against the building and a wood covering for the water meter, and generally the shade of the large tree on that side (Photo 41).

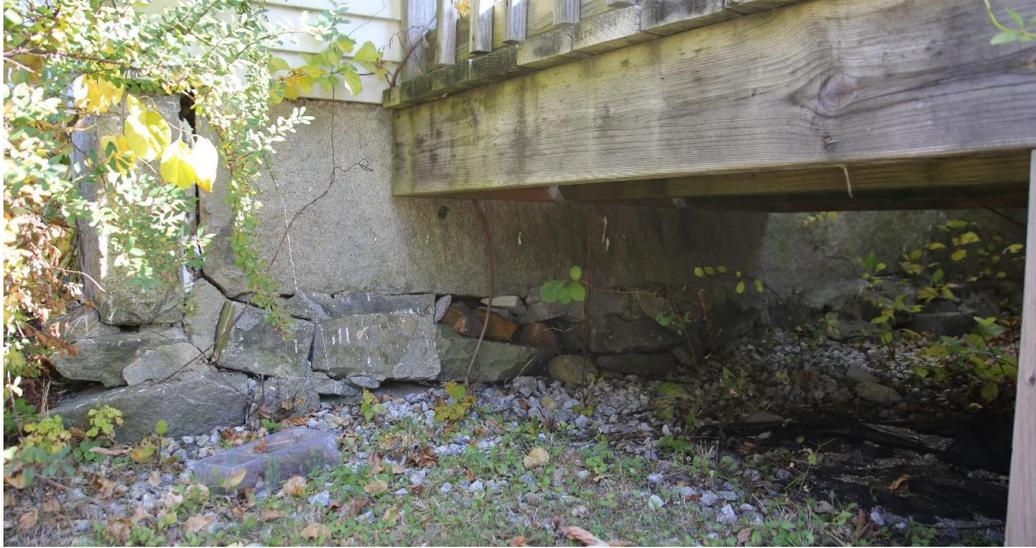
*Photo 40: Southwest corner foundation, showing loose stones and open joints. Stair landing to storage room at right.*

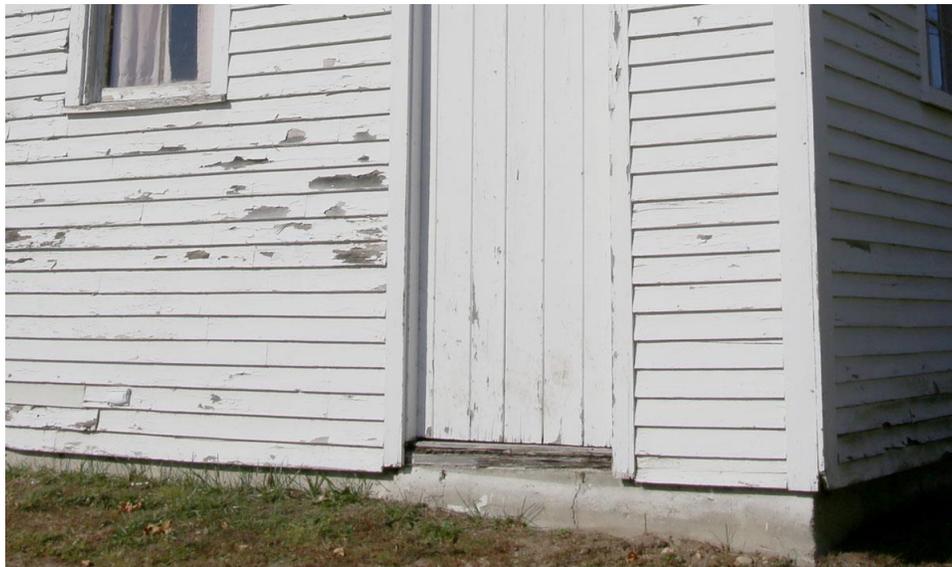
The poured concrete foundation from the 1984 addition is in good condition. A couple of minor cracks are visible beneath the door on the east elevation. The wood door sill above this area is in poor condition and rotted. The cracks should be repaired or at least monitored, and a new sill with flashing should be installed in the doorway.

*Photo 42: Cracks seen in the concrete foundation beneath the deteriorated door sill on the east elevation.*

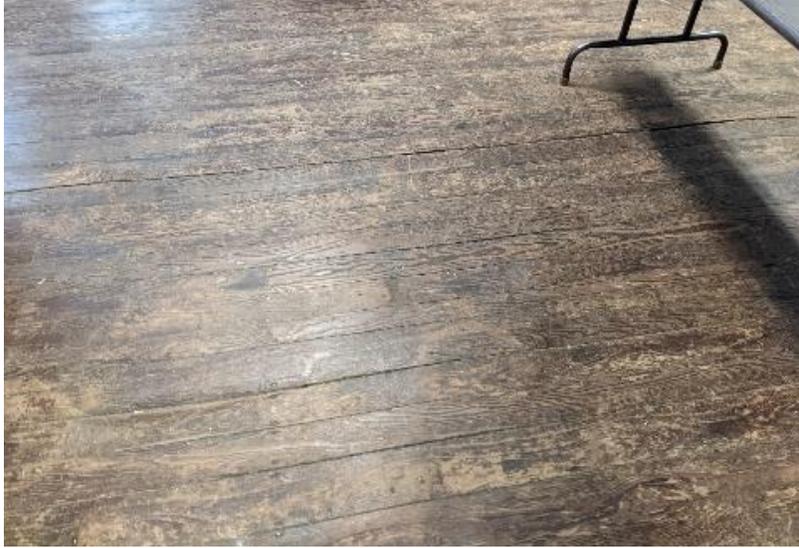
The flooring in the older building is a stained, 3" softwood (pine) that has an uneven surface and is worn by many years of use. It has a clear finish that has darkened over time. However, the floor is structurally in very good condition with no areas of rot, splitting, or weakness.

*Photo 44: The flooring in the main room is slightly uneven due to age and use but is in good condition (Flynn).*

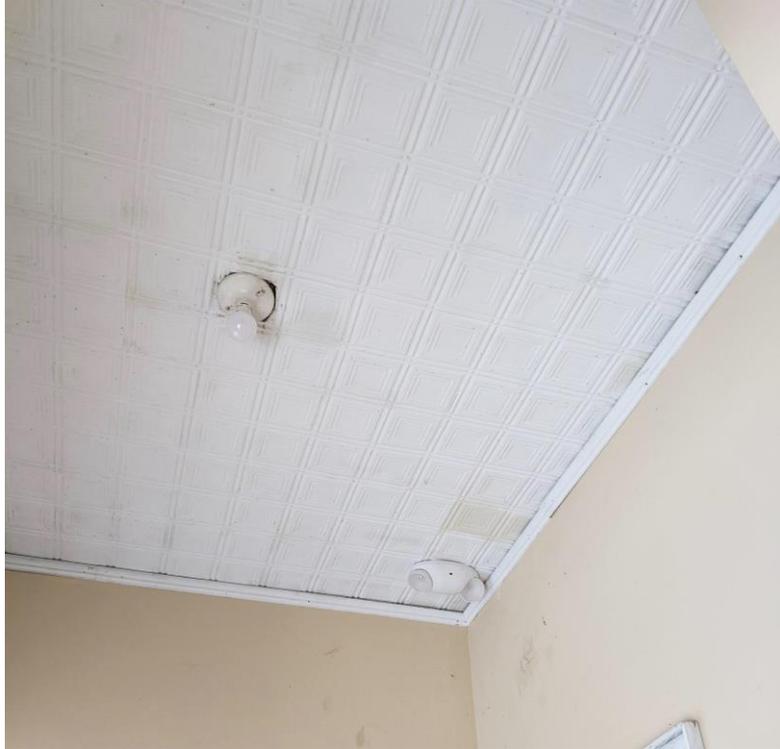
*Photo 45: Pressed metal ceiling in the lobby needs painting but is in good condition (Flynn)*

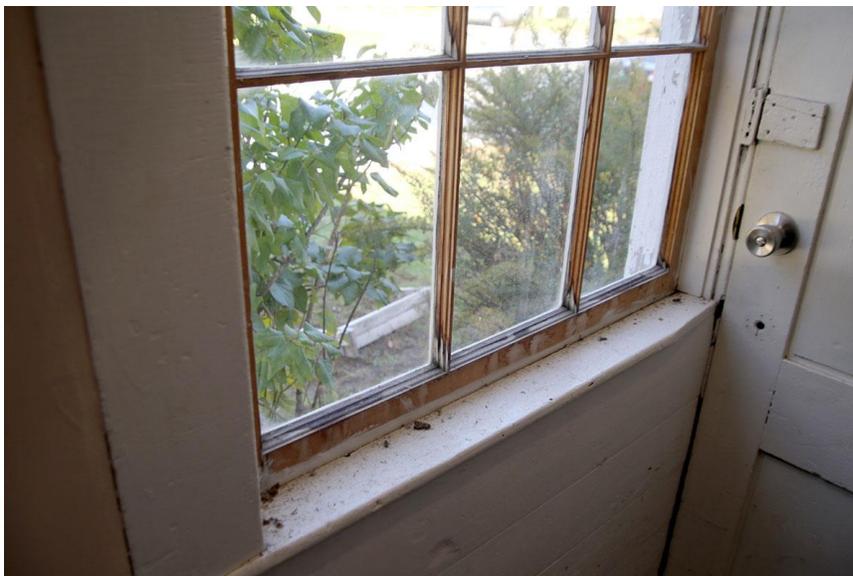
The windows are in variable condition depending on their location in the building and their age. The two 4-over-4 windows on the north side were restored in 2021 to operable condition. The 6-over-6 window on the west façade is in poor condition and needs restoration. UV and water damage (from condensation) is apparent on the unpainted interior of the sash.

*Photo 48: Interior of the 6-over-6 window on the west façade, showing water and UV damage.*

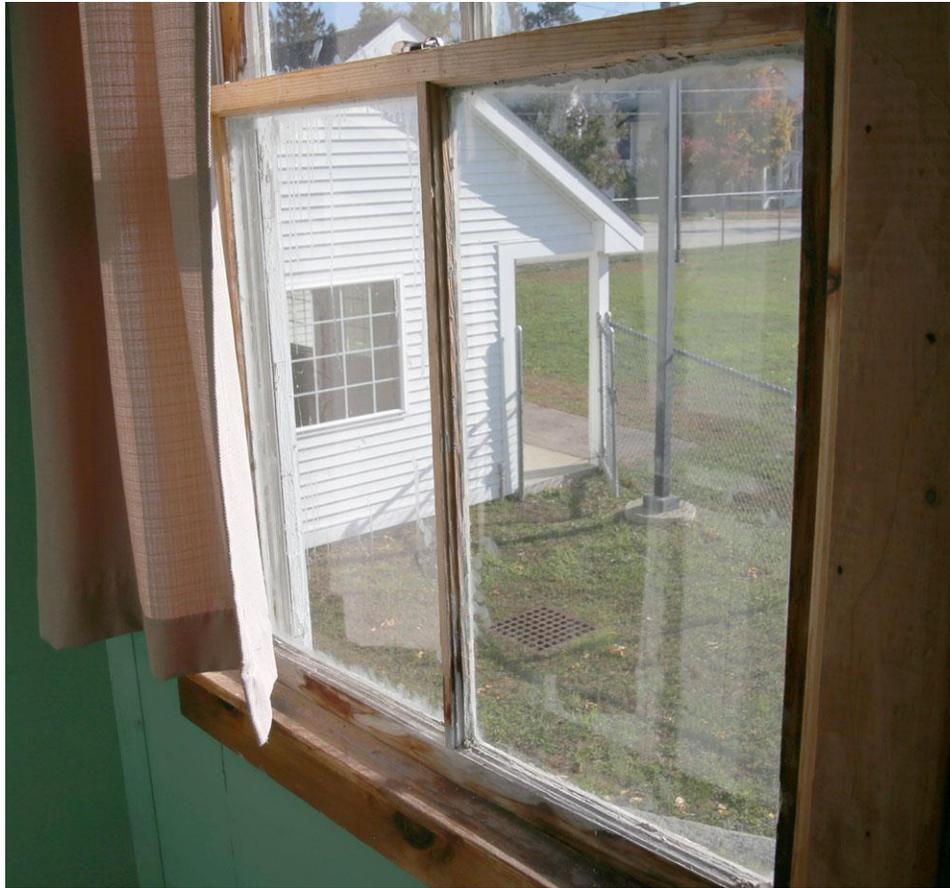
*Photo 49: Interior of the 2-over-2 sash, showing deterioration of the wood and sill.*

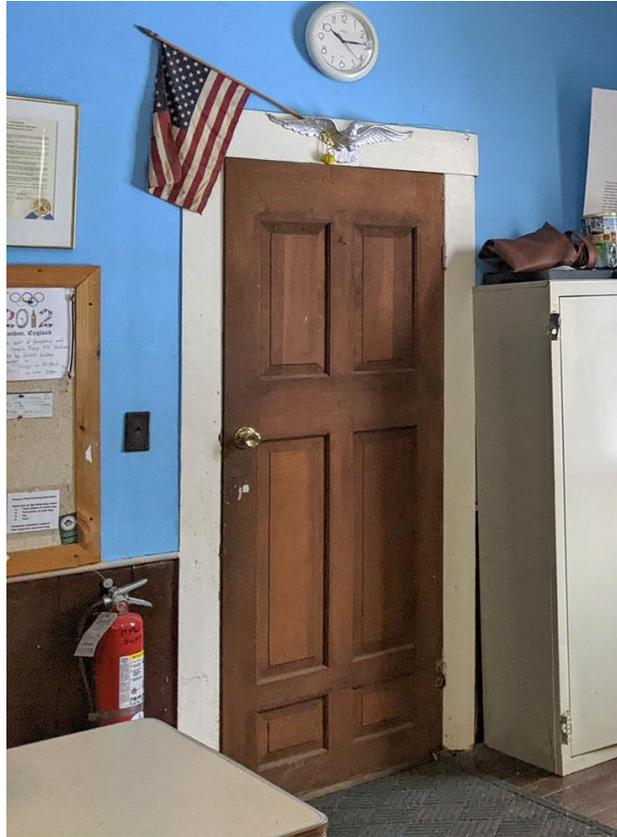
*Photo 50: Door between the lobby and the main room is in good condition but has been hung upside down, making the knob height high.*

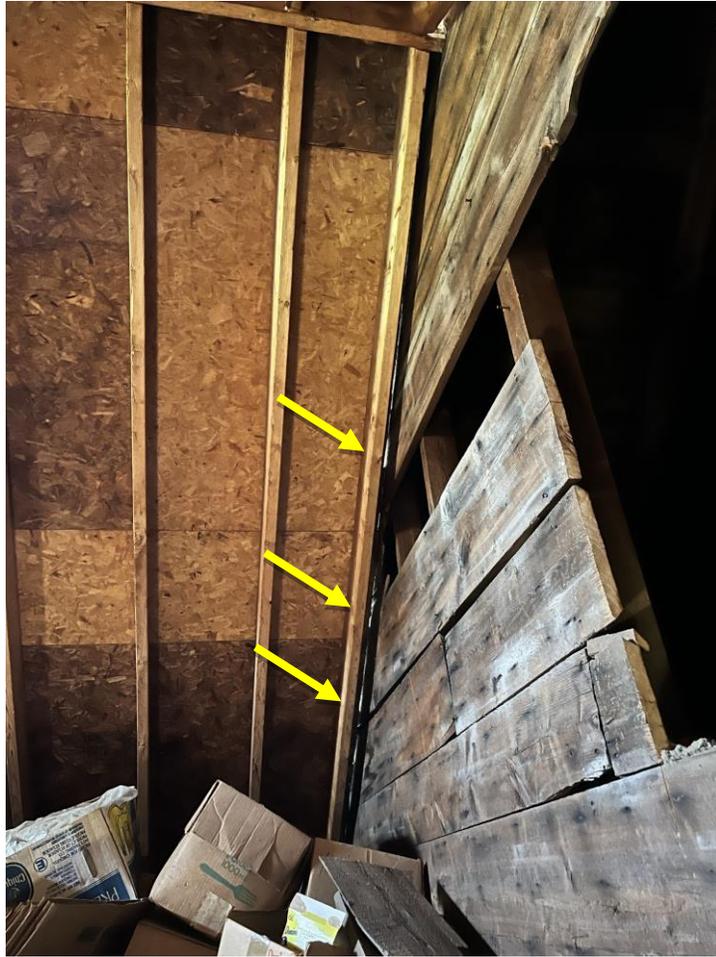
*Photo 53: Gaps seen between the framing of the roof addition and the older building's east elevation (arrows)*

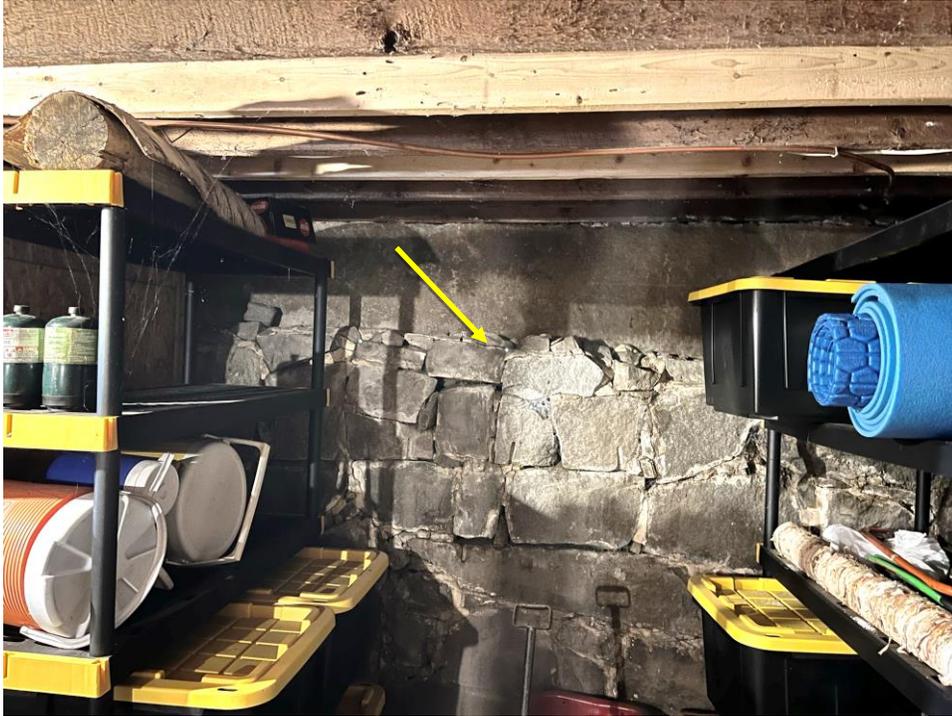
*Photo 54: Granite foundation wall, north wall, showing loss of mortar and several areas of light shining through from the exterior (shown with arrow)*
