27 ELM ST ASSESSMENT REPORT

TOWN OF MILFORD, NEW HAMPSHIRE FACILITY CONDITIONS ASSESSMENT

127 ELM ST, MILFORD NH

SEPTEMBER 10, 2020

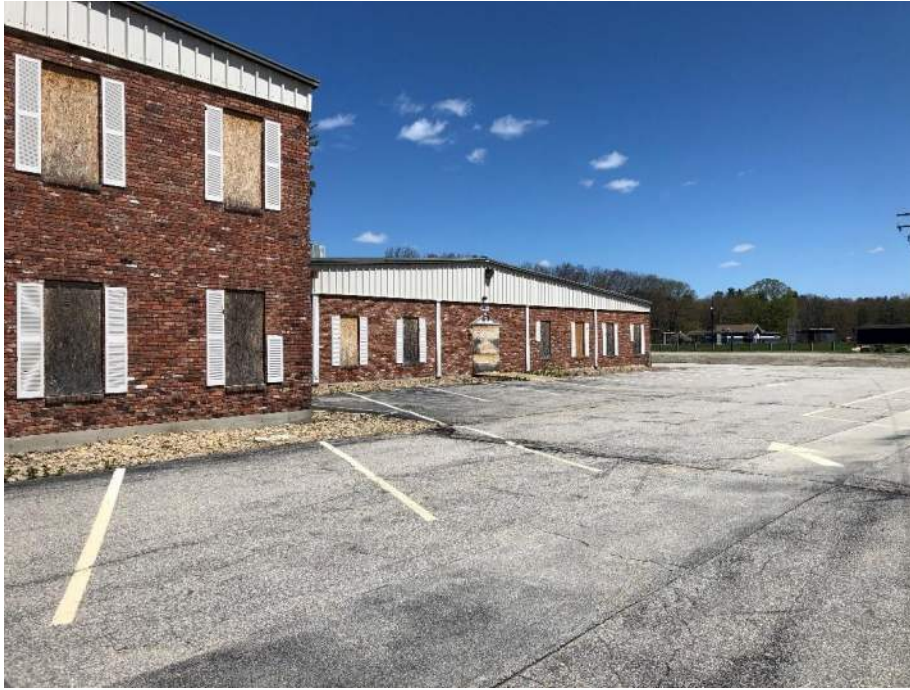
View of typical pavement condition

The asphalt paving should be repaired or replaced. Parking lot layout and flow should be analyzed to achieve maximum efficiency and capacity. If possible the overhead power to the west edge of Keyes Park should be relocated underground. Surface run-off drainage should be analyzed and a means to handle the run-off should be designed if not currently existing. The site lacks exterior site lighting. There are building mounted lights that should be assessed and replaced as required. Adequate site lighting for safe movement through the parking lot should be installed.

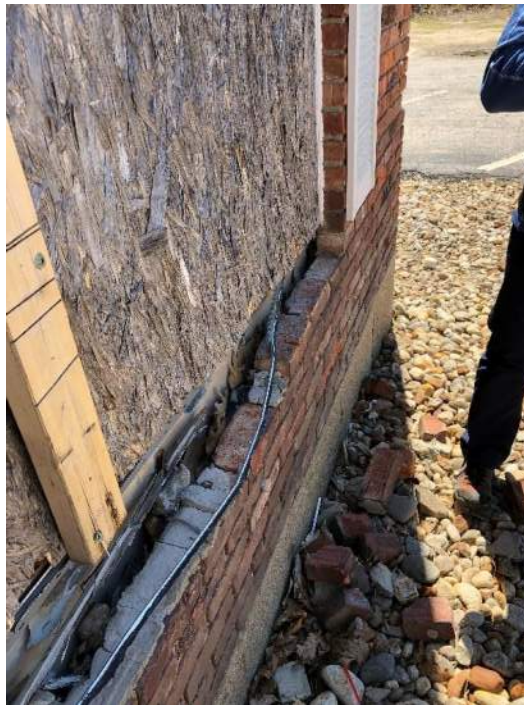
View of failing brick veneer and back up wall below a window opening

As noted above the exterior walls would require extensive repair both to the metal siding and brick veneer should the building be re-used. The back up framing behind the brick veneer would require some partial demo of wall finishes to fully assess the repairs needed.

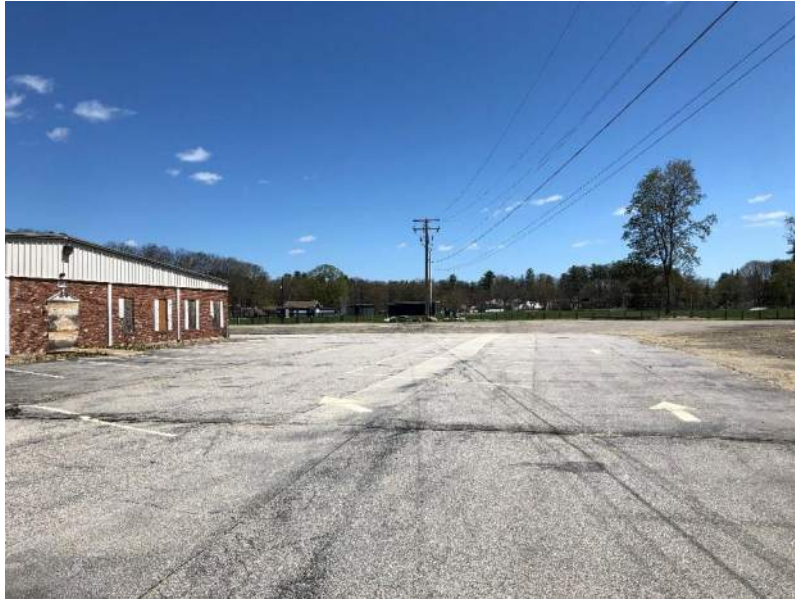
View of overhead power and view out to Keyes Park

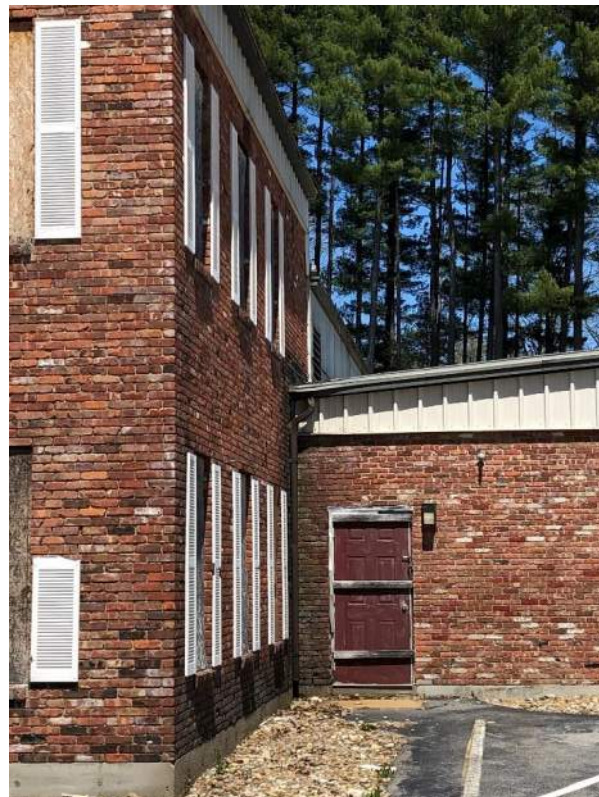
View of roof pitching into sidewall

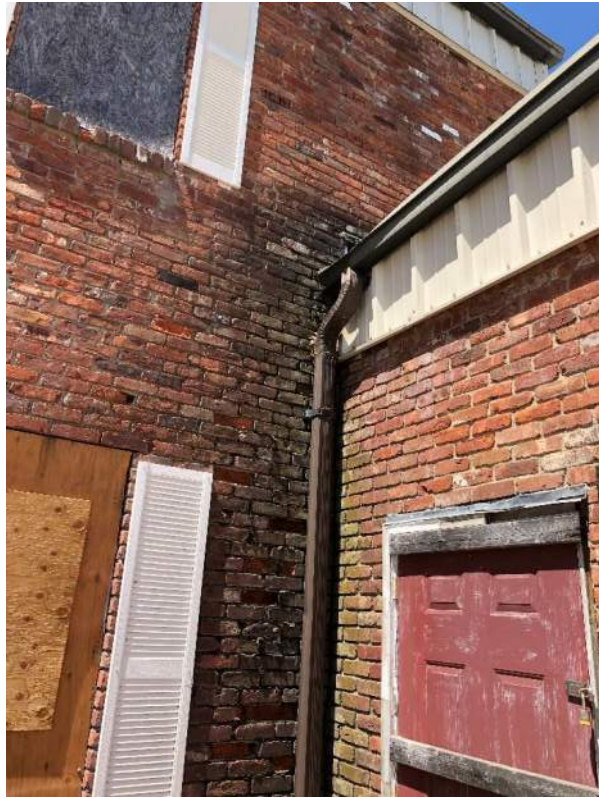
View of brick damage at interior corner

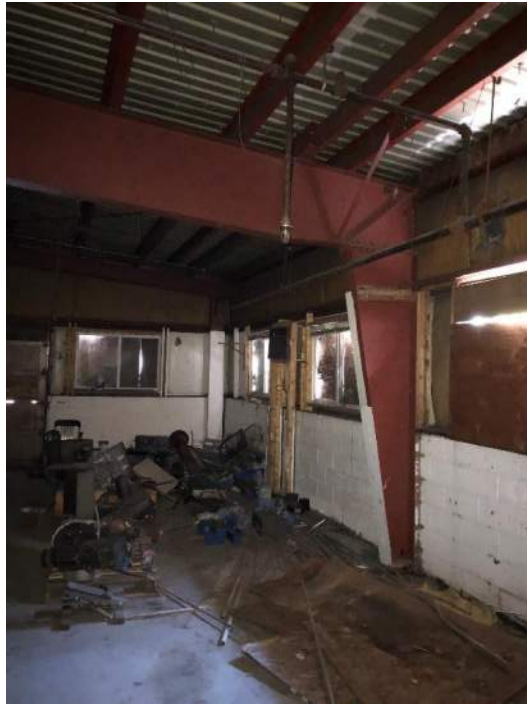
Typical metal building frame – bents and roof purlins

The steel frame elements appear to be in good shape and don't need immediate attention.

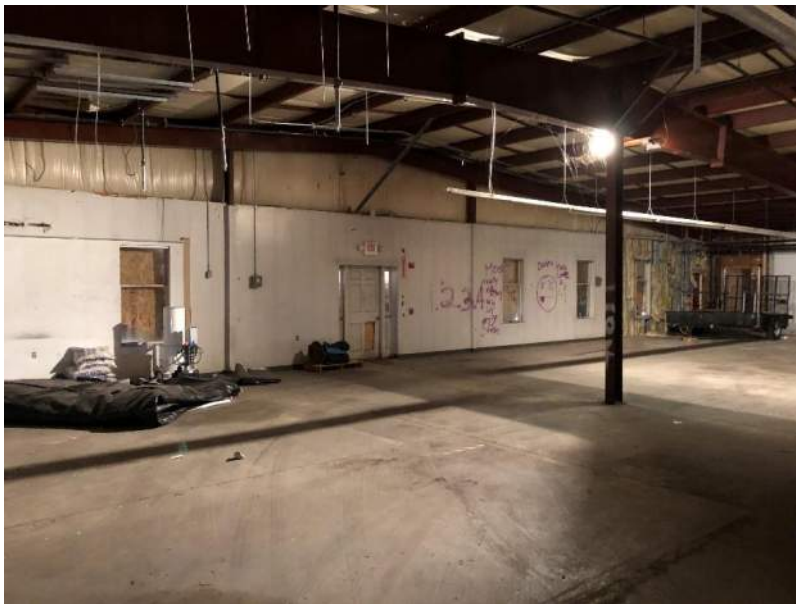
Metal building frame @ easternmost building showing columns along ridge line

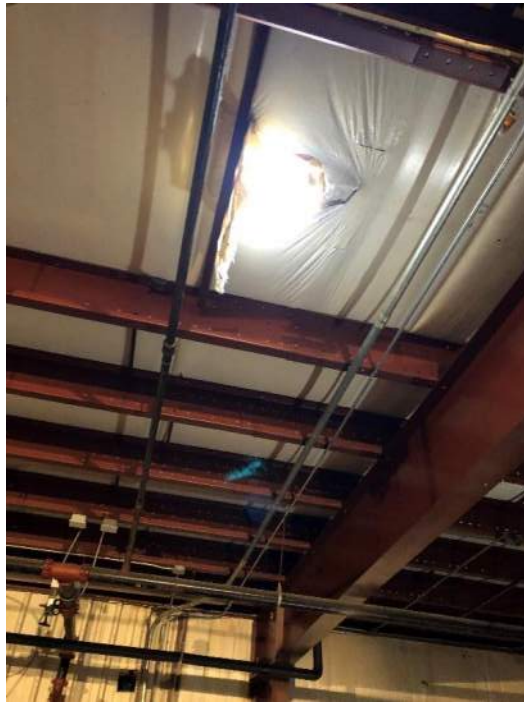
Daylight through hole in insulation, vinyl layer and roof panel

concept of shedding water, snow, and ice away from building surfaces. The hole in the roof in the easternmost building should be fixed immediately.

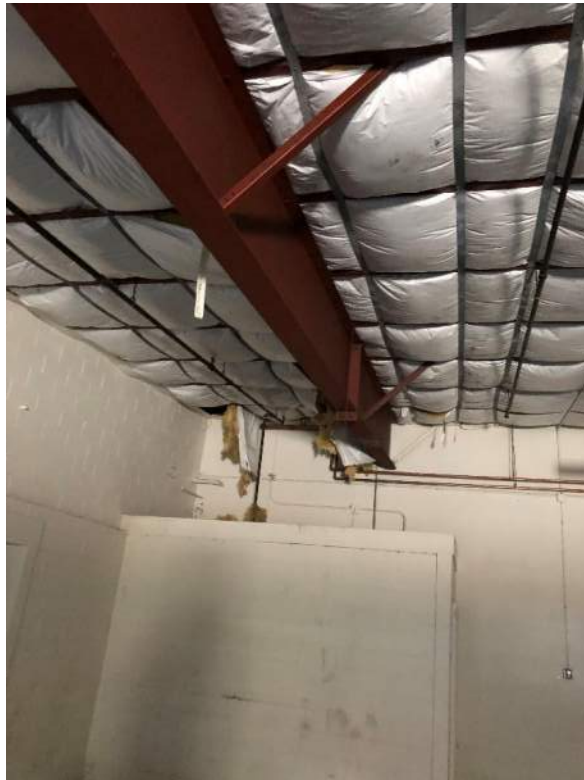
Typical roof insulation with vinyl facing and support strapping

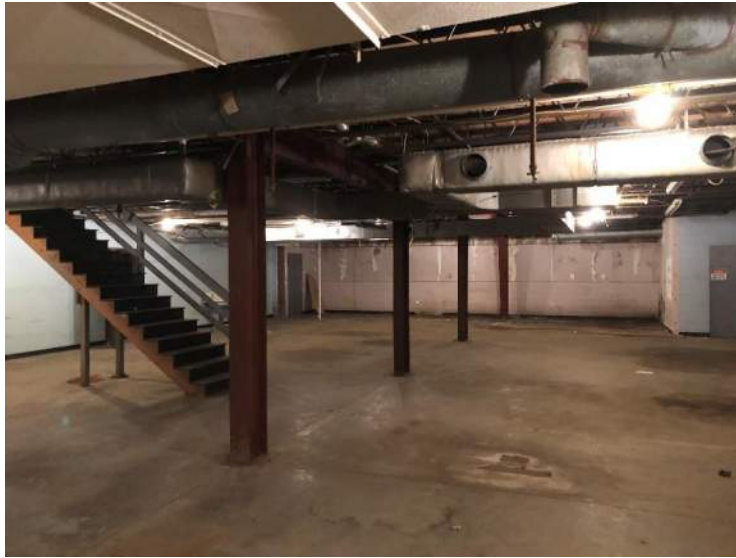
The second floor of the middle building is accessed by wood framed stairs. The stairs were in good condition but lacked proper guard rails and hand rails. Code compliant guard rails and hand rails would need to be added.

Wood stairs to second floor in middle building

Address guardrail and handrail issues.

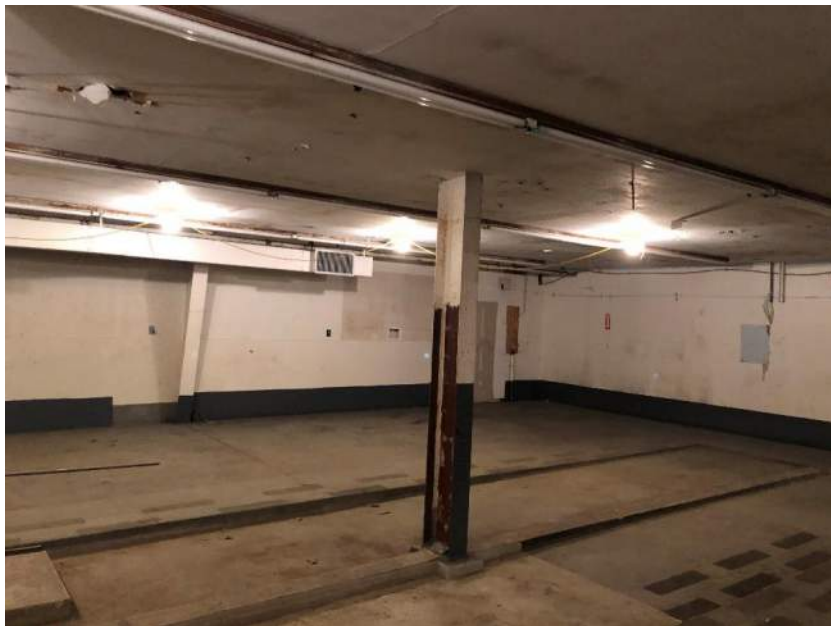
The concrete slabs on grade appear to be in good condition. The east and west building floor slabs are relatively clean and level. The middle building floor slab has numerous depressions, pits and a dock leveler at the rear of the building space. These depressions are assumed to have been built for specific industrial processes and would need to be leveled and in-filled in any re-use scenario. Slab moisture levels and below slab moisture prevention measures are not know at this time but can contribute to added and unforeseen costs in a renovation.

View of slab in middle building showing multiple levels
