McLane and Goldman Dams National Register Integrity Assessment Milford, New Hampshire

August 1, 2011
PAL No. 2506

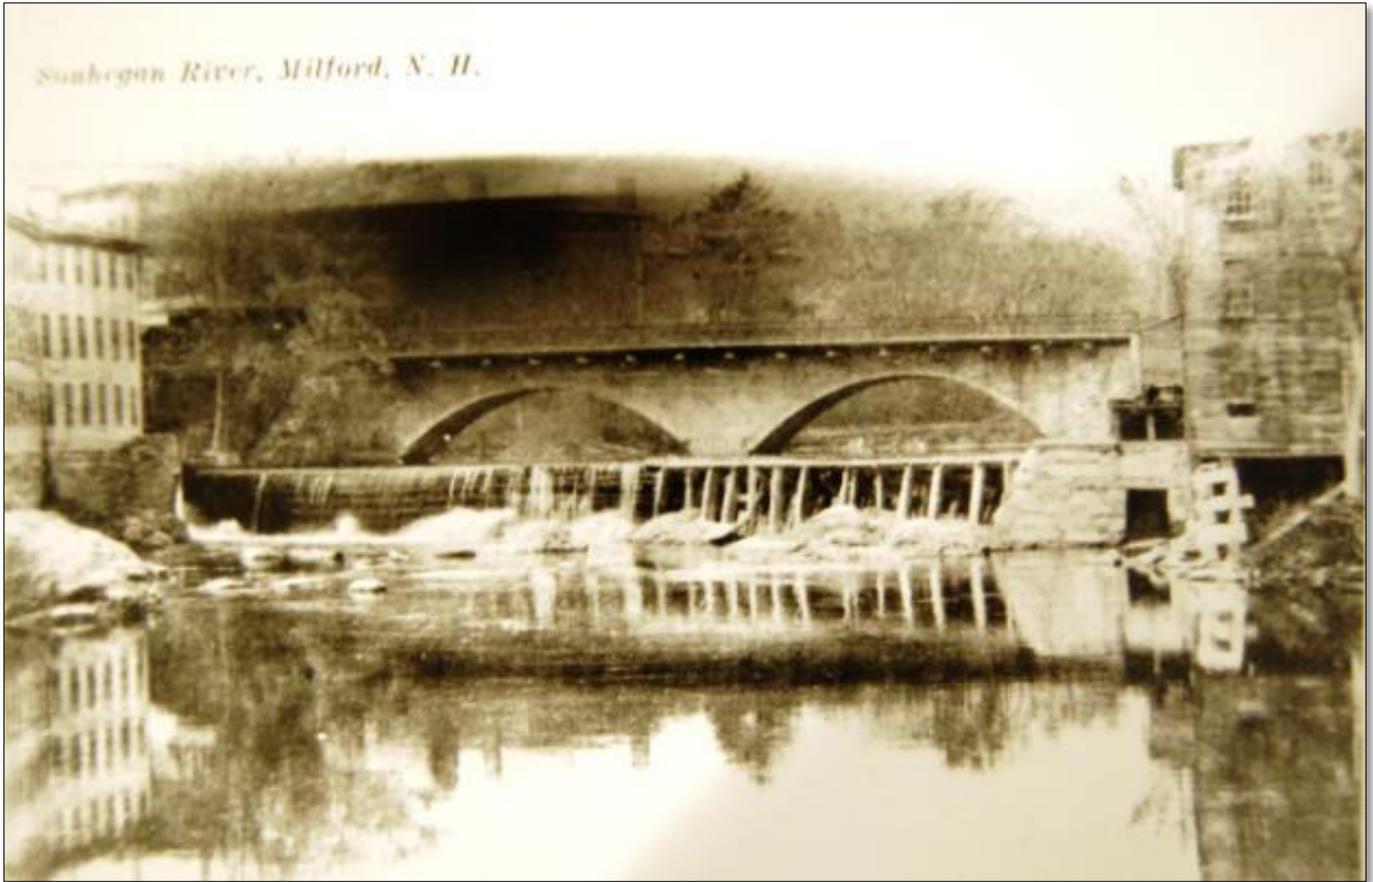
Figure 1. View of the Goldman Dam between 1885 and 1924, looking west (upstream). Timber crib and timber A-frame portions of spillway are shown on left and right, respectively. The stone low-flow outlet (a/k/a sluiceway) at the right end of the spillway is extant, but has been altered through its partial encasement in concrete (source: Milford Historical Society Photograph Collection: P-890).

Throughout the period of significance for the district, the Goldman Dam’s defining feature was its timber crib and frame spillway (Figures 1–3). In cross-section, the dam approximated a right triangle with a shallow sloping, wood-plank upstream face and a near-vertical downstream face. The dam designers would have relied on stone rubble within the cribbing and iron pins driven into the rock ledge in the steam channel to allow the dam to withstand the mass of water upstream of the dam. The sloping upstream profile of the spillway would have supplemented this resistance by transferring some of the lateral force of the water down through the dam into its substructure and underlying stream bed. Tight-fitting wood planking provided the dam with the ability to retain water and directed debris in the river up and over the dam. In plan, the dam crossed the Souhegan River in three legs at varying angles. Cribbing was utilized in the southern-most leg, while timber bents were used on the other two legs, which were over exposed bedrock. The difference in construction techniques across these legs was probably a response to the changing river channel conditions. Cribbing would have provided a better solution for a soft river channel bottom, while bents could more readily be anchored into the exposed ledge and the frame structure more easily adapted to this irregular surface. At the north end of the spillway was a stone culvert low-flow outlet. This was operated using a vertical-lift gate whose mechanism rested on a headframe atop the outlet.

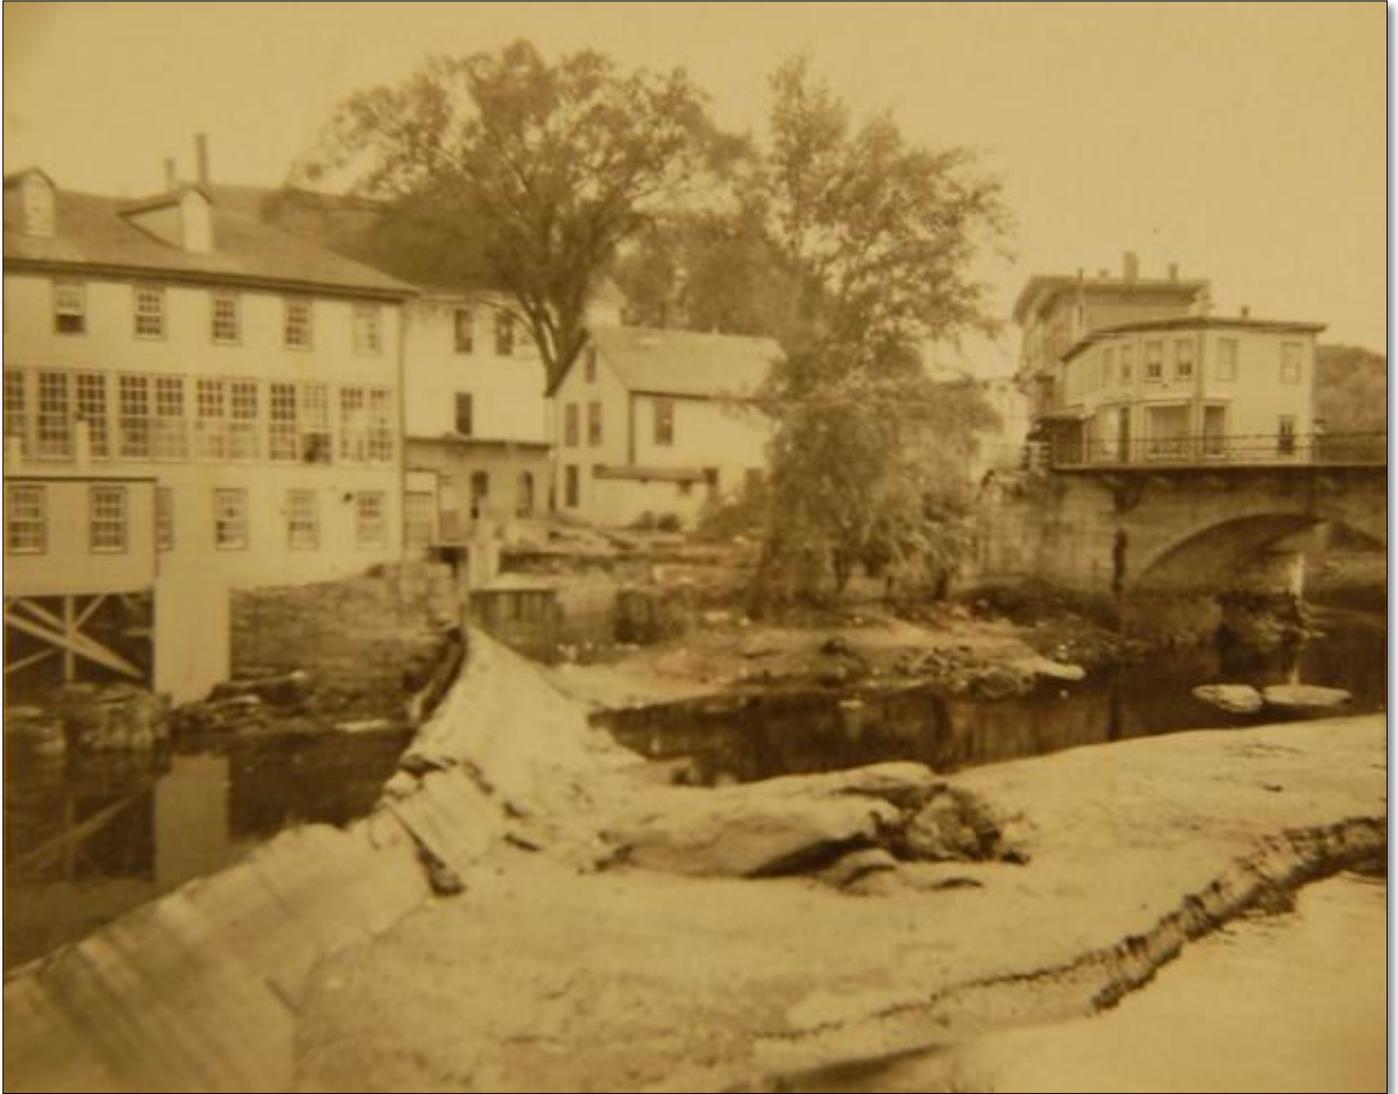
Figure 2. View of the Goldman Dam between 1912 and 1924, looking south (river flows right to left) (source: Milford Historical Society Photograph Collection: P-1020).

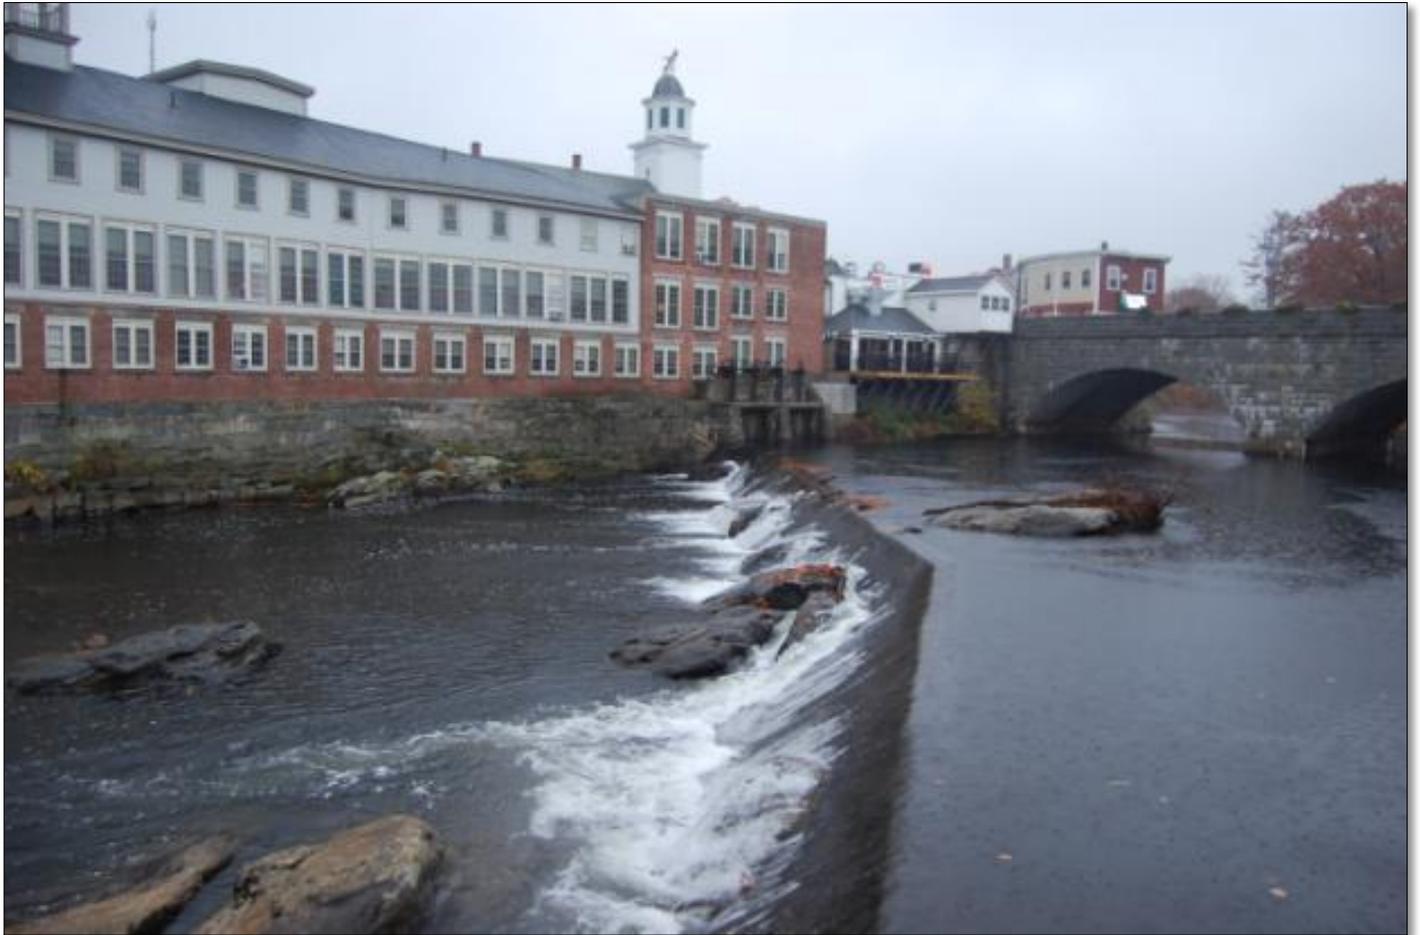
Figure 6. View of current Goldman Dam, looking southwest.

In 1966–1967 the Town of Milford removed the historic dam spillway, which constitutes approximately 170 feet (or 87 percent) of the dam’s 195-foot length, and replaced it with a concrete gravity structure, a completely different type of construction than the previous dams at the privilege (Figures 4–7). This change was not a singular alteration to one aspect of the structure’s integrity (materials), but occurred within shifting engineering practices that allowed for fundamental changes in the form, structure, and style of the resource. As a result, the design integrity of the nineteenth-century timber crib dam was lost.

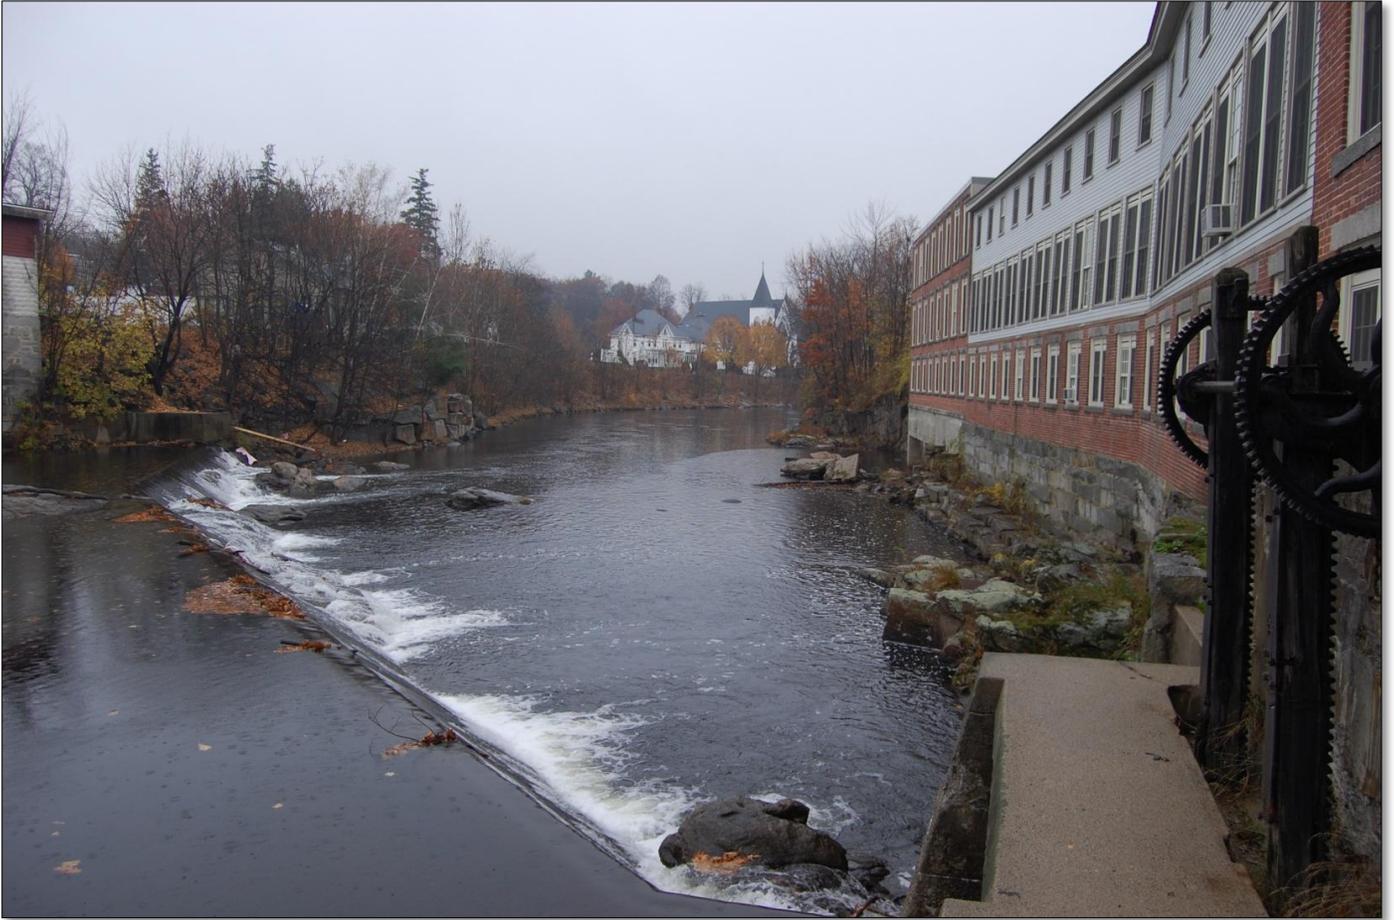
Figure 7. View of current Goldman Dam, looking northeast.

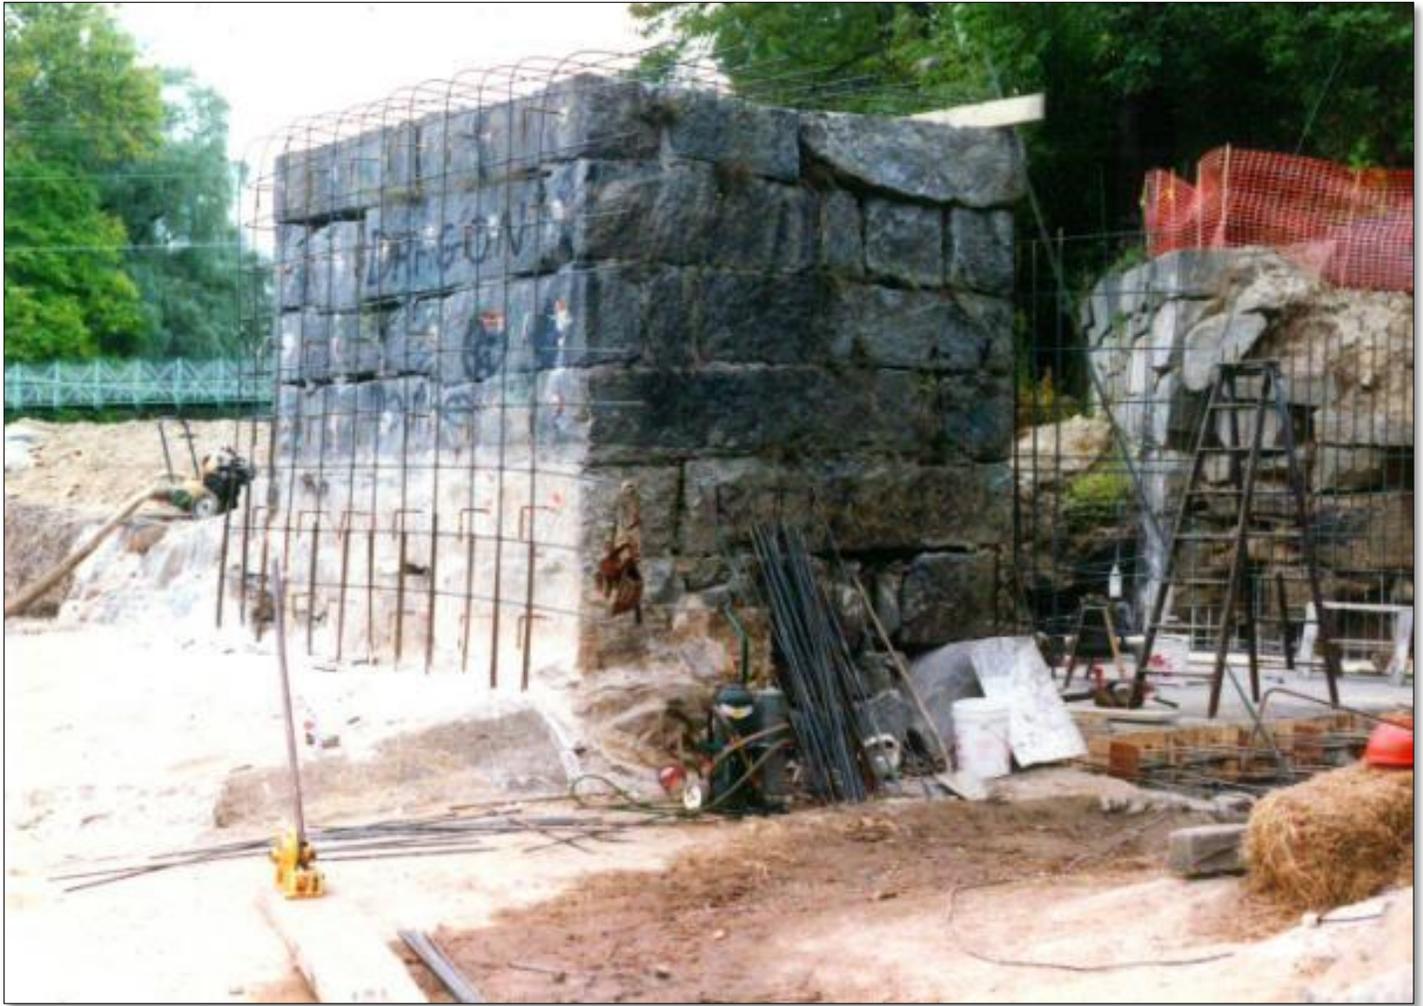
Figure 14. View of the McLane Dam gate during 1992 dam rehabilitation, looking north. Pier in center foreground is still extant, now encased in concrete. To the right of pier, the old wood gate structure, a second stone pier, and the top of power canal have been completely removed (source:Anonymous ca. 1992).

“dog leg” spillway has a stone core built in 1846 that is surrounded by up to 2 feet of concrete from a 1909 rehabilitation, and between 1 and 1.5 feet of additional concrete added in 1992. The overall length of the west spillway was reduced by about 11 feet, and the east spillway reduced by 1 foot. The crest of the dam has been raised between 0.5 and 1.0 foot, depending on the location. A concrete apron also was added to the downstream side of the west spillway leg, covering and/or filling a former low-flow outlet at the base of the spillway. New reinforced concrete abutment walls were built in front of the earlier stone abutments on the east and west river banks. The stone and wood gate structure at the east end of the dam was severely altered. Two wood gate leaves, the gate frames, and a granite pier adjoining the gate on the east river bank were removed and replaced with the current steel and concrete stop log slots and wood stop logs. Concrete cladding covers three of four elevations of the remaining granite pier west of the gate. The upper portion of the power canal, where it connected to the gates, was removed, so the stoplogs now function as a low-flow outlet rather than a canal gate.

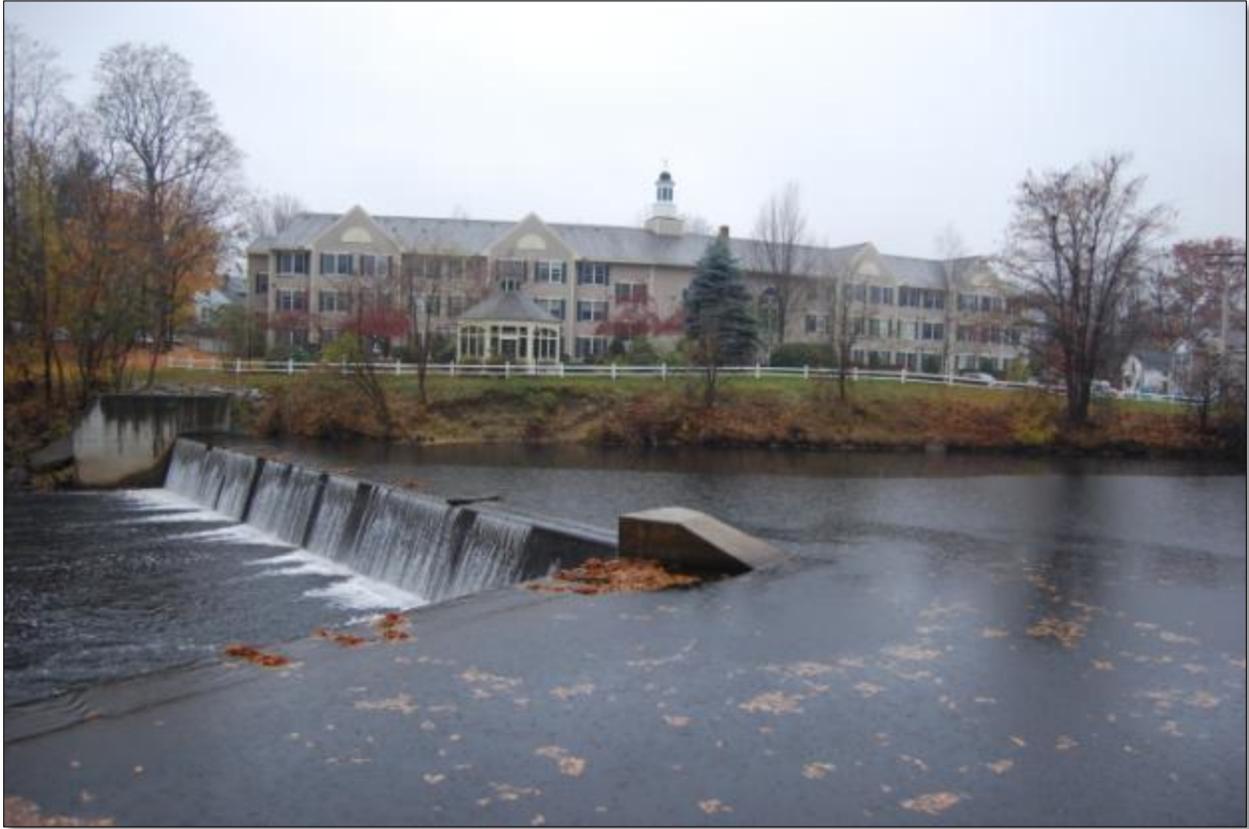
Figure 15. View of McLane Dam, looking west (compare to Figure 6). The industrial setting and infrastructure on the river's west bank is entirely gone, destroying the structure's association with the industrial and commercial development of the Downtown Milford HD.

The McLane Dam was intended to function as a source of power for industrial and, later, hydroelectric enterprises on both the east and west banks of the Souhegan River. The industrial resources on the river’s west bank consisted of wood mill loft structures used for manufacturing between 1842 and 1935. The mill lofts were immediately proximate to the west end of the dam, and powered by a short raceway at this location. Neither the mill lofts nor the raceway survive on the west bank, which is now occupied by an apartment complex (compare Figures 8 and 15). On the east bank, an approximately 1,200 foot-long power canal supplied power to the Souhegan Mill (demolished) between 1848 and 1872. The canal then supplied a hydroelectric facility at the same location as the mill between 1890 and an unknown date in the 1940s. The upper 40 feet of canal adjacent to the dam is demolished, and the lower 600 feet of canal adjacent to the former hydroelectric powerhouse are filled. The powerhouse is highly altered and is located outside of the boundaries of the Downtown Milford District. Because of the missing industrial and hydropower fabric at the east and west ends of the dam, the dam no longer reflects the manufacturing and hydroelectric functions that it was intended to serve. The McLane Dam therefore lacks integrity of setting.

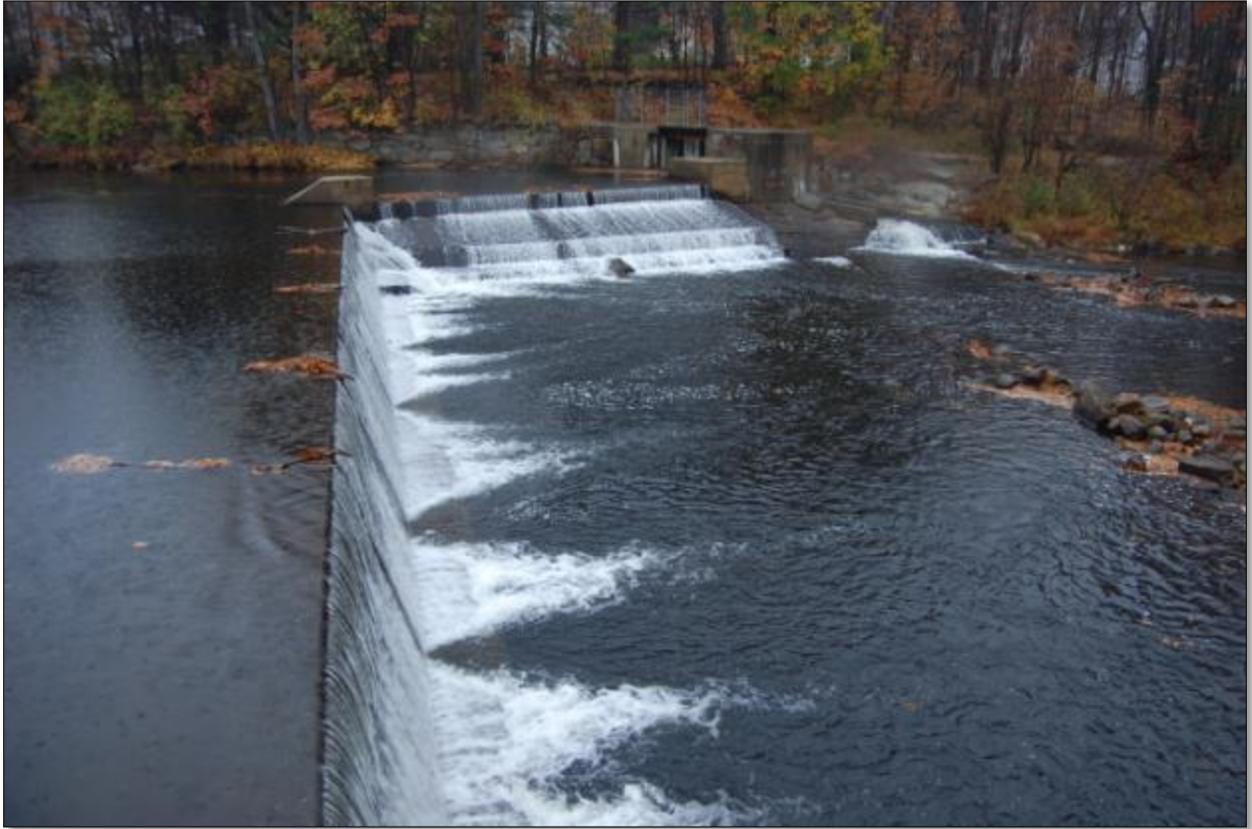
Figure 16. View of McLane Dam, looking east (compare to Figure 7). The former power canal where it connected to the dam is demolished.

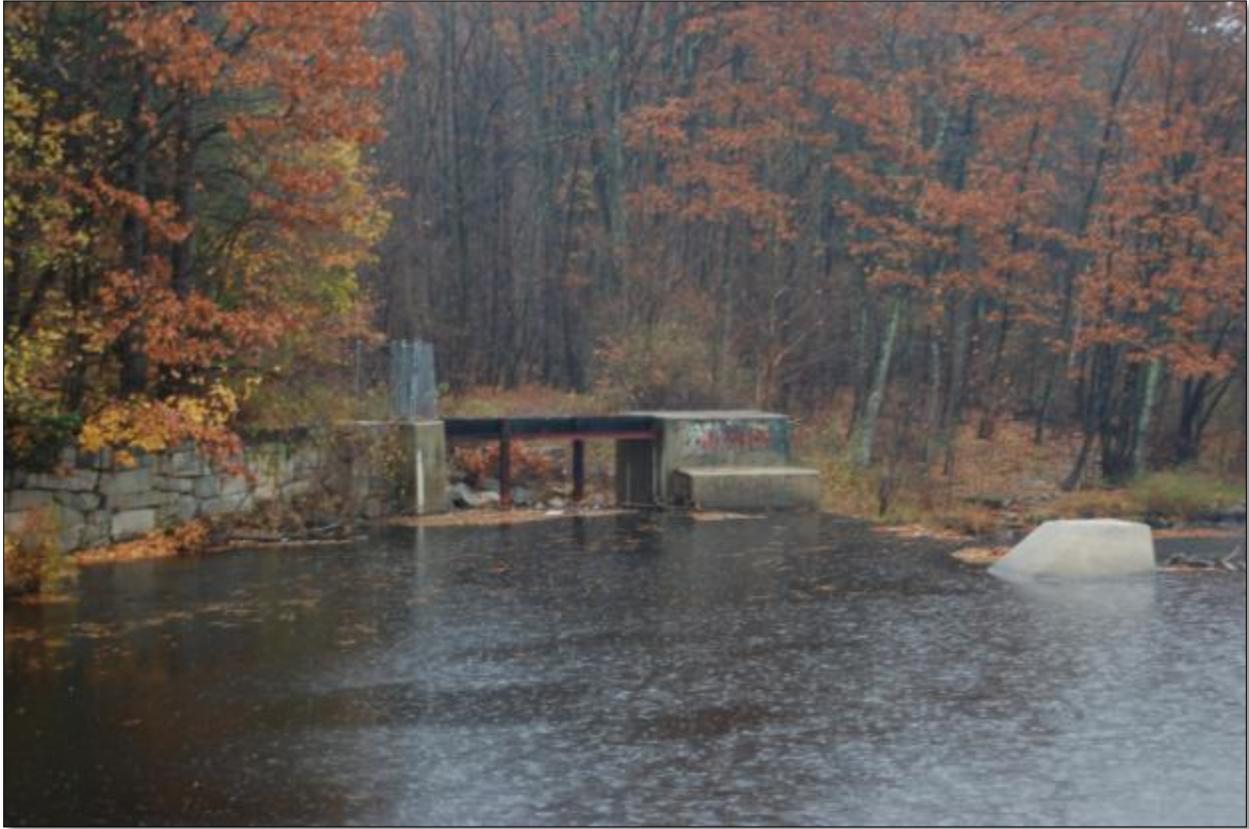
Figure 17. Detail of McLane Dam low-flow-outlet, looking south (compare to Figure 8).
