# Historic Building Conditions Assessment Report

Abbott/Laurel Schoolhouse  
7 Shepard Street, Milford, NH

May 2023

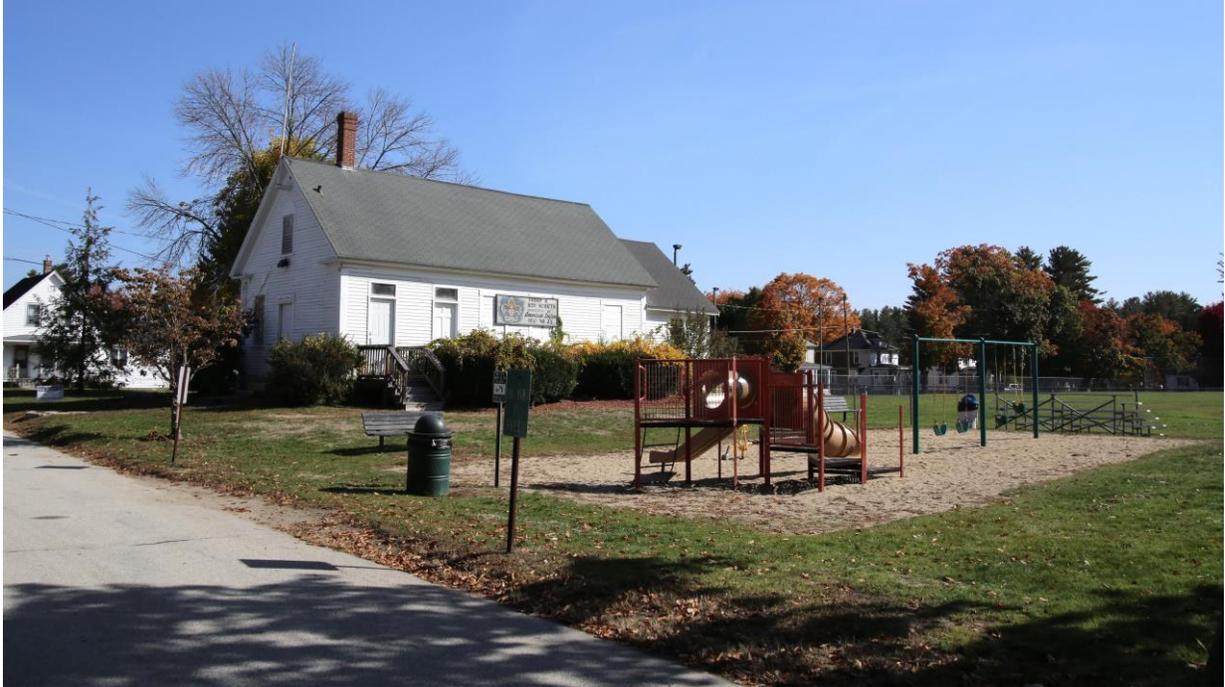
*Photo 2: Schoolhouse and Playground at Shepard Park*

The vegetation on the south side of the building is overgrown and has been placed too close to the building (see Photo 2, page 6). This situation can cause moisture to be retained against the building and foundation. A large propane tank is also located in the middle of the south façade, alarmingly close to the building. The large tree on the north side of the building also adds to moisture retention in that area.

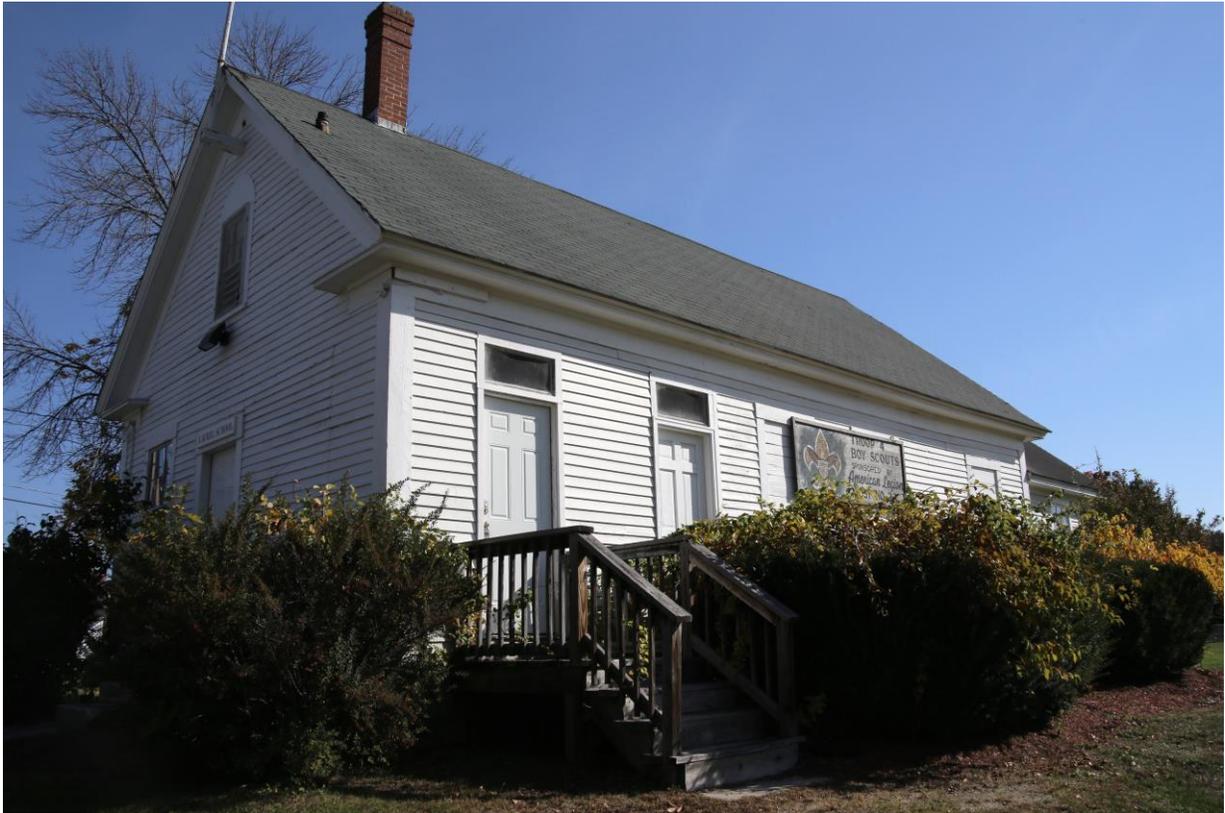
*Photo 5: The roof is asphalt shingled with an interior chimney and plumbing vent in the southwest corner.*

The brick stove chimney is no longer in use and is generally in good condition, though uncapped. The exterior shows some need for maintenance and repointing of the topmost courses of bricks.

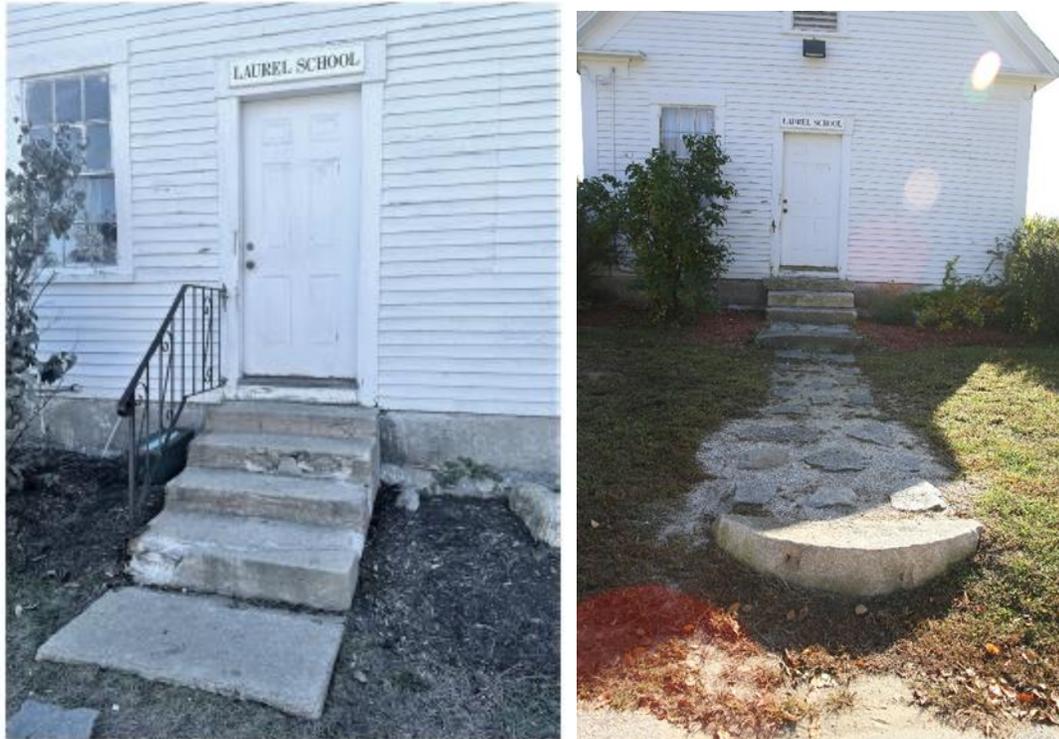
*Photo 6: At left, poured concrete steps in 2021 (Palance)*

*Photo 7: At right, new granite steps in 2022*

The building is approached on a newly installed path of granite stones and salvaged granite block steps, replacing poured concrete steps in 2022. An earlier iron railing was removed at this time, but a new custom iron railing is planned to replace it. Photos in the 1970s show the stairs as wooden.

The stairs leading to the main entrance on the west façade have been recently replaced with salvaged granite stones with an irregular stone path approach (see Photo 7, page 18). A new handrail is planned to be installed and should be done soon for the safety of the users of the building. The wooden steps leading to the storage closet on the southwest corner is made of pressure-treated wood and is generally in good condition.

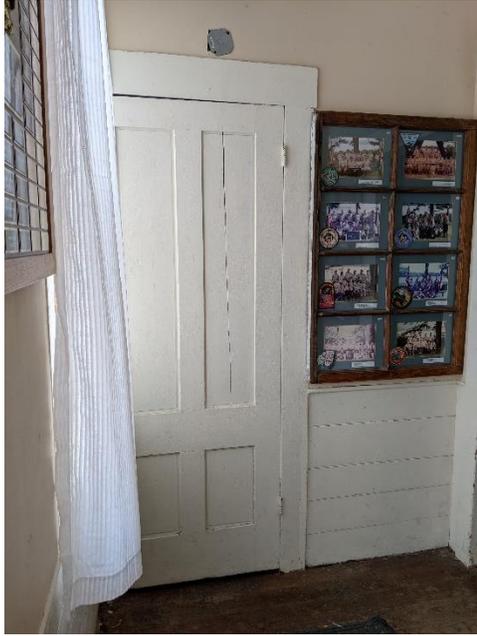
*Photo 14: Basement door at left*

The doors are all in good condition but vary in age and style. The oldest door in the building, at the basement stairwell in the northwest corner (Photo 14, page 24), has a split in one of the upper panels and needs painting. Other than surface abrasion it is in good, functional condition. The door to the main room from the lobby is a 6-panel door, likely dating to the mid-twentieth century, in good condition though it has been hung upside down. This causes the location of the doorknob to be higher than usual, and it may lead to accessibility problems, especially for children (see Photo 50 below).

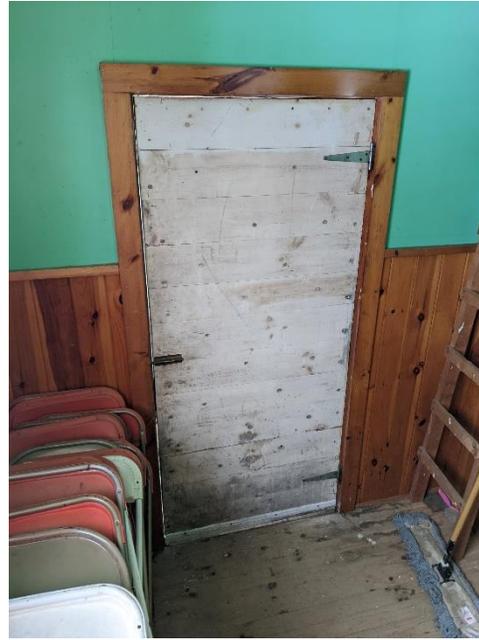
*Photo 15: Rear door of addition at right (Flynn)*

The rest of the interior doors in the building date to the 1970s or 1980s and are flat, hollow-core wood doors. They are all in good, working condition. The east exterior door, added in 1984, seems to be made of scrap wood panels and is more like a shed door (Photo 15). A better insulated door should be added in this location for energy efficiency.

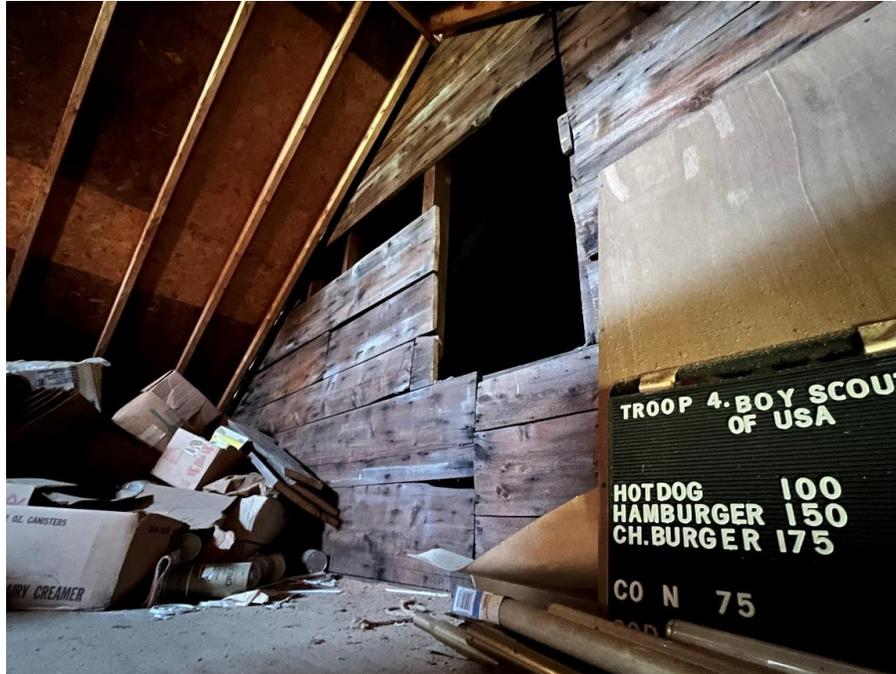
*Photo 23: Roof rafters and plywood sheathing in rear addition and exterior sheathing of main building, east elevation.*

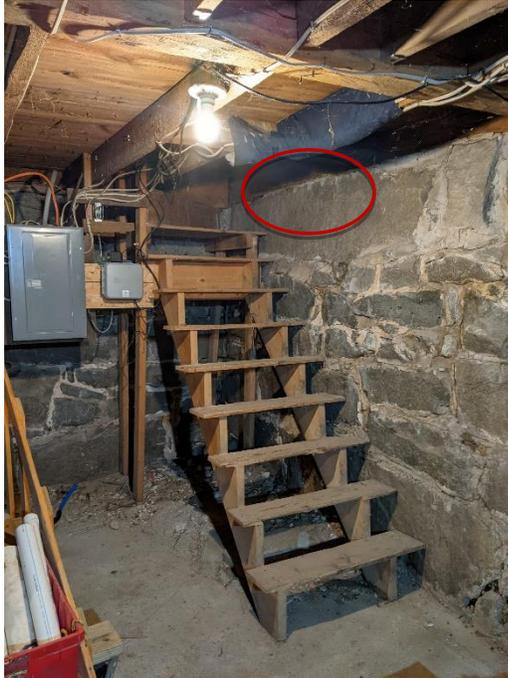
*Photo 24: Original granite foundation with marks (pre-1830) laid on top of irregular cut granite scrap (Flynn)*

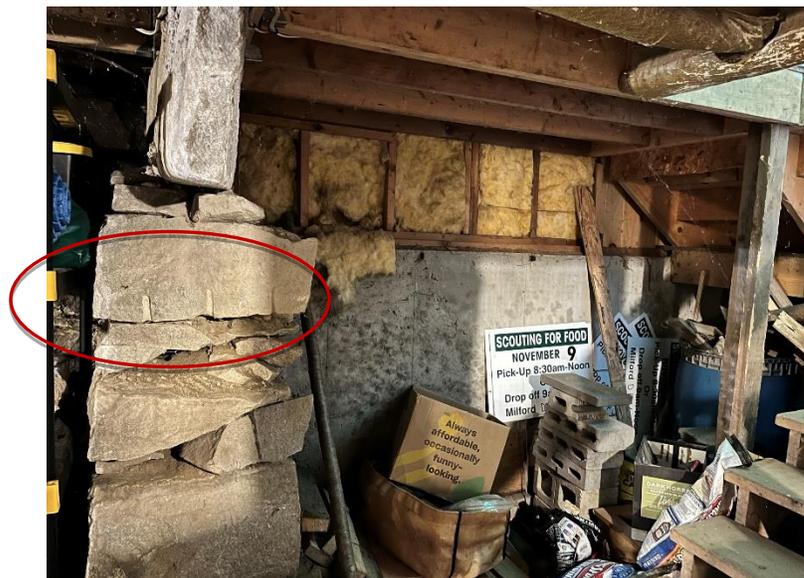
*Photo 25: Granite block support with plug and feather chiseling (post-1830) and concrete foundation under rear addition (at right).*

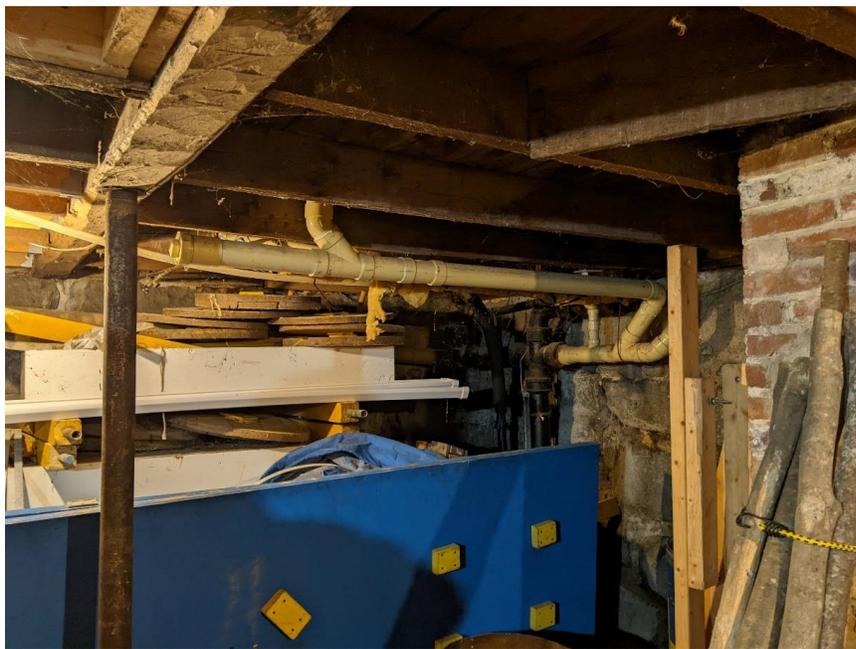
The foundation, frame, walls, and general form are typical of nineteenth century construction. Multiple updates, likely recycled materials from the earlier pre-1830 building, are evident. One example of this would be hand-hewn beams, left uncut on three sides (Photo 27, Page 29).

*Photo 27: Handhewn main floor beam, above left, and waste line, chimney to the right (Flynn)*

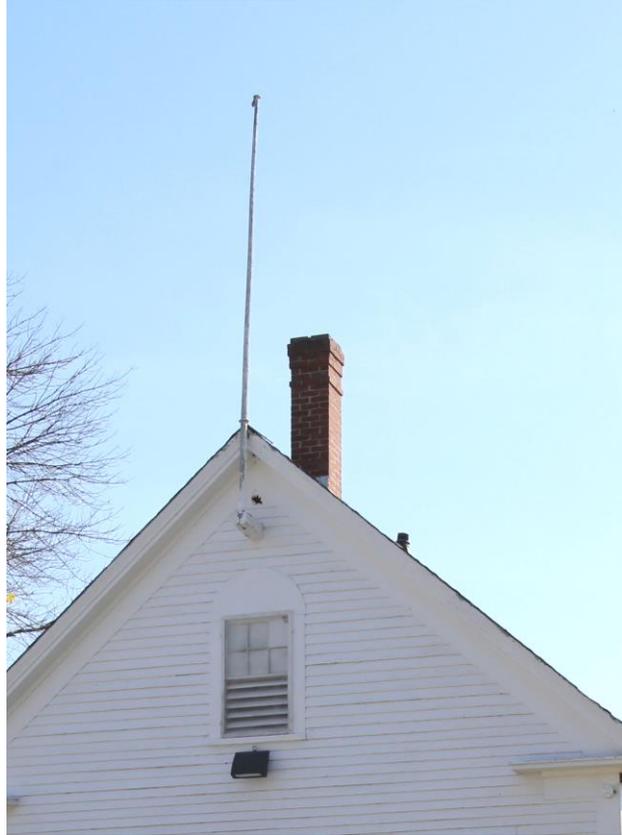
*Photo 33: Flagpole and hole just beneath the peak of the gable on the façade.*

The flagpole mounted to the gable peak on the façade has lost most of its paint, and a hole is visible just behind it in the uppermost clapboard. This hole may have been used for access to the rope to raise and lower the flag.

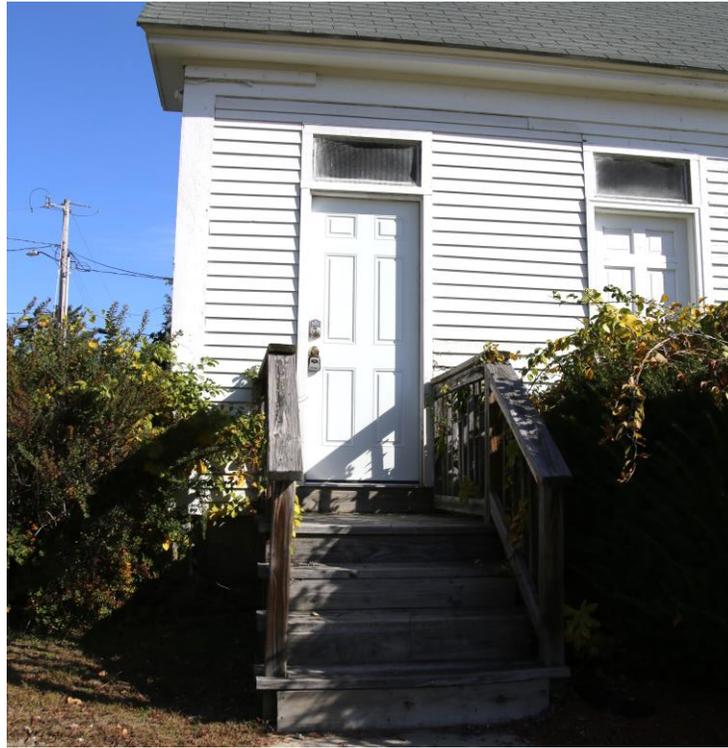
*Photo 34: Wood stairs leading to the storage room at the southwest corner.*

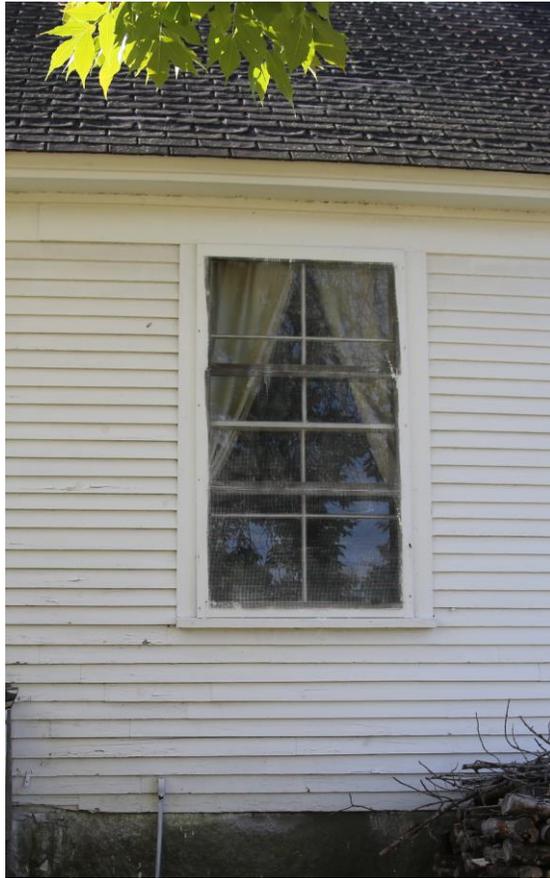
*Photo 35: 4-over-4 window on the north side, recently restored, with wood-framed screen affixed to the exterior.*

Several of the windows have been recently restored in a window workshop sponsored by the town in the fall of 2021. This work included the two 4-over-4 double-hung windows on the north elevation. The 6-over-6 windows, also on the west and north elevations, are twentieth century replacements but show UV damage on the interior and paint loss on the exterior. The 2-over-2 window on the rear is a reused window, as it predates the 1980s addition, and needs new paint and window glazing.

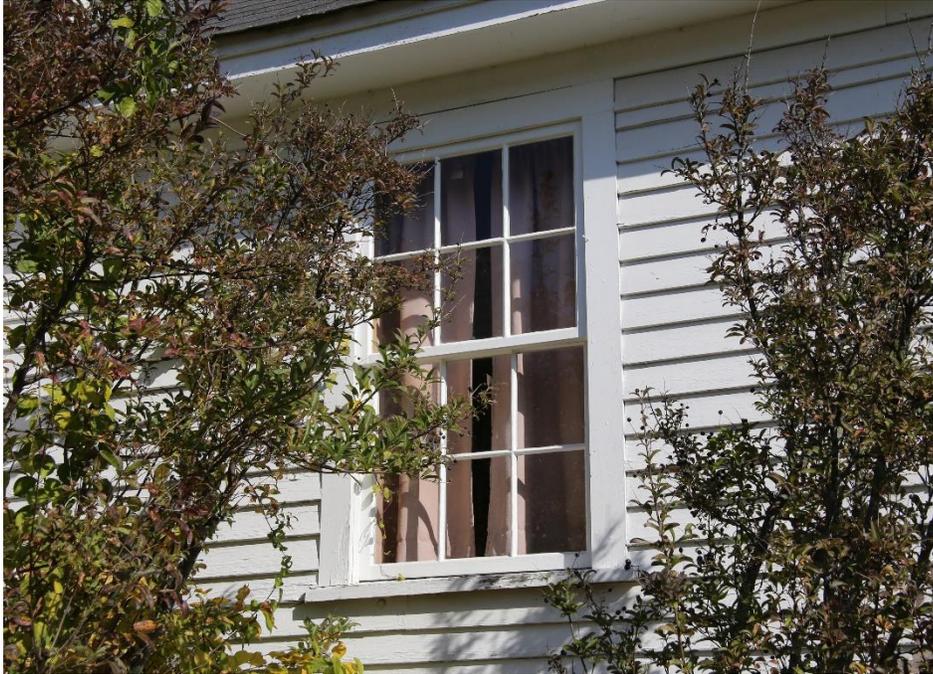
*Photo 36: 6-over-6 window on the south side of the addition.*

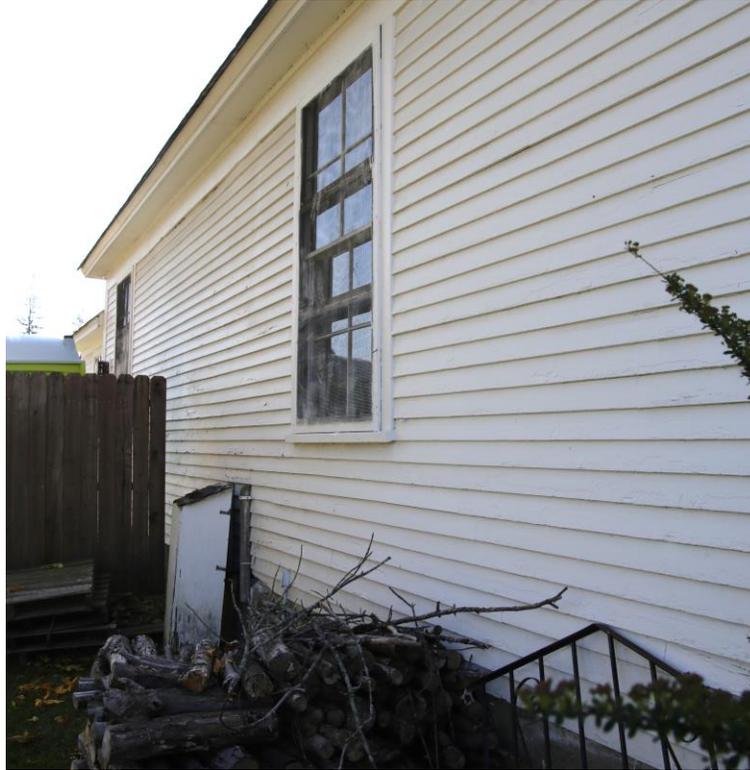
The foundations of the original building are mortared granite rubble capped with limestone blocks. The exterior exposure of the foundation shows several areas where the mortar has deteriorated, leaving open gaps between stones. The original mortar was most likely lime-based, and modern repointing efforts using Portland Cement have been inadequate. The north side of the building has areas of biogrowth, evidence of moisture retention especially behind a woodpile stacked against the building and a wood covering for the water meter, and generally the shade of the large tree on that side (Photo 41).

*Photo 41: North side of the building, showing 4-over-4 window. Woodpile and water meter with cover just beyond. Paint visible on the foundation blocks.*

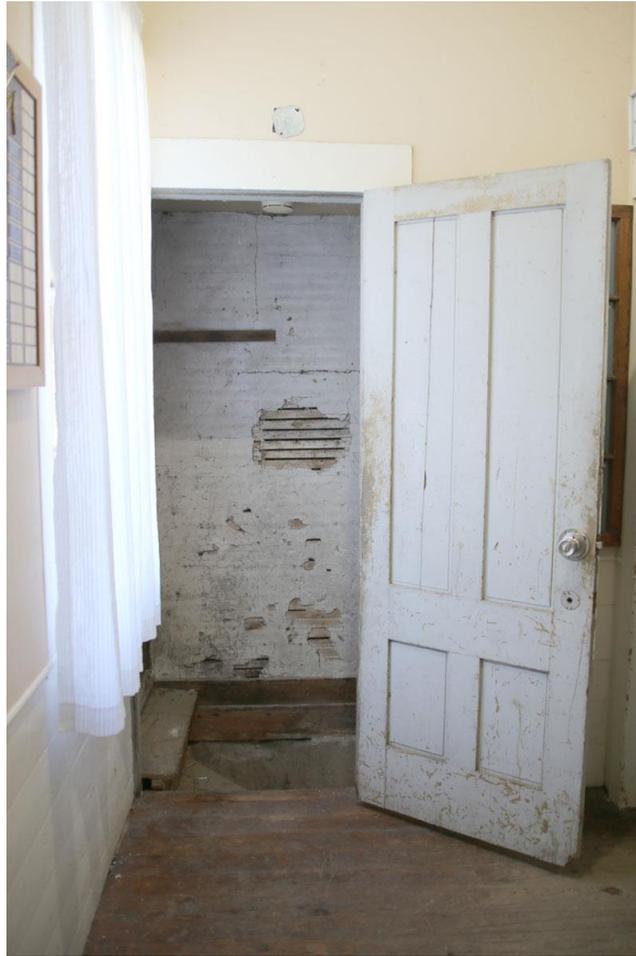
*Photo 43: Doorway in lobby to the basement stairs, showing unfinished plaster on lath. Door likely dates to before 1900, around the time the building was relocated.*

The interior finishes are generally in good condition. Interior walls and partitions have been added and altered since the building's move in 1898. Most of the interior walls are made of gypsum board or drywall, though the wall of the stairway to the basement in the northwest corner has unfinished plaster and some areas of exposed lath. The walls in the "lobby" also retain their painted plaster above the horizontal board wainscotting.

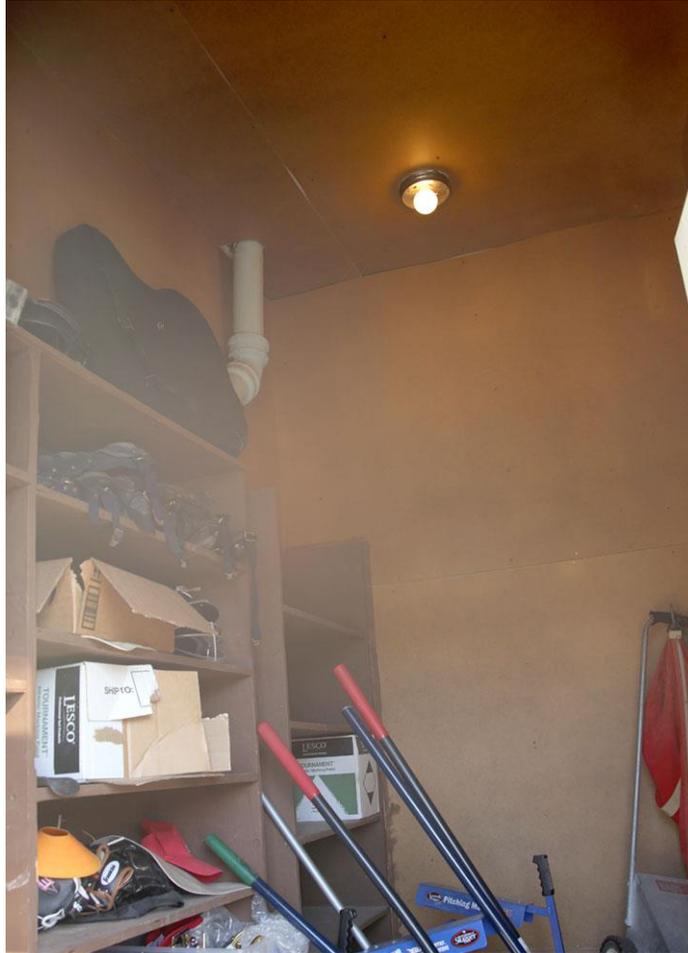
*Photo 46: Interior of the storage room, showing MDF panels applied on the surface of the walls and ceiling. Cast iron vent pipe seen at upper left.*

The interior of the storage closet in the southwest corner has been recently covered with Medium Density Fiberboard (MDF) panels, and the floor is of plywood. Wood shelving along the west wall has been built around the painted, cast iron plumbing vent that rises from the basement and exits through the roof above this location. The MDF is currently in good condition, but it is a temporary finish that will lose its structural form quickly, especially in an unconditioned space. This room will likely need to be refinished in the next ten years, depending on the use.

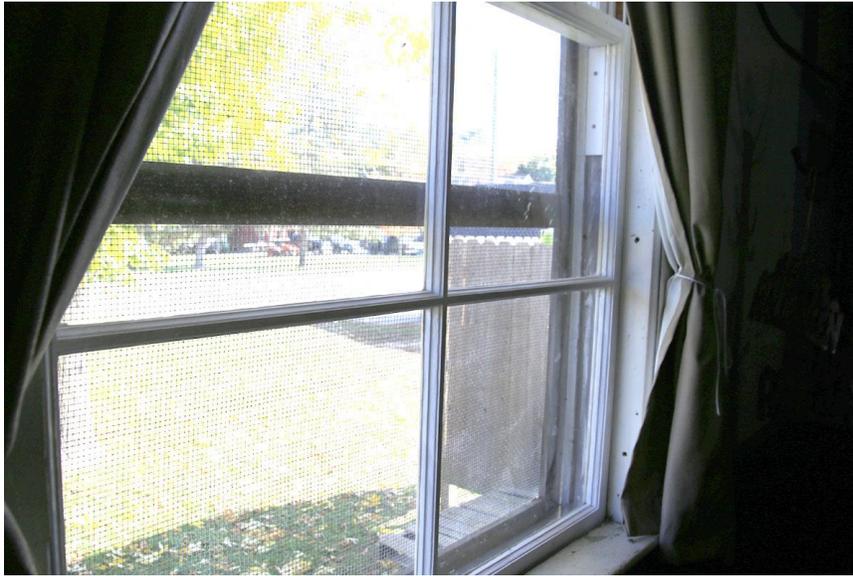
*Photo 47: Interior of the 4-over-4 window on the northwest side, recently restored.*

The windows are in variable condition depending on their location in the building and their age. The two 4-over-4 windows on the north side were restored in 2021 to operable condition. The 6-over-6 window on the west façade is in poor condition and needs restoration. UV and water damage (from condensation) is apparent on the unpainted interior of the sash.

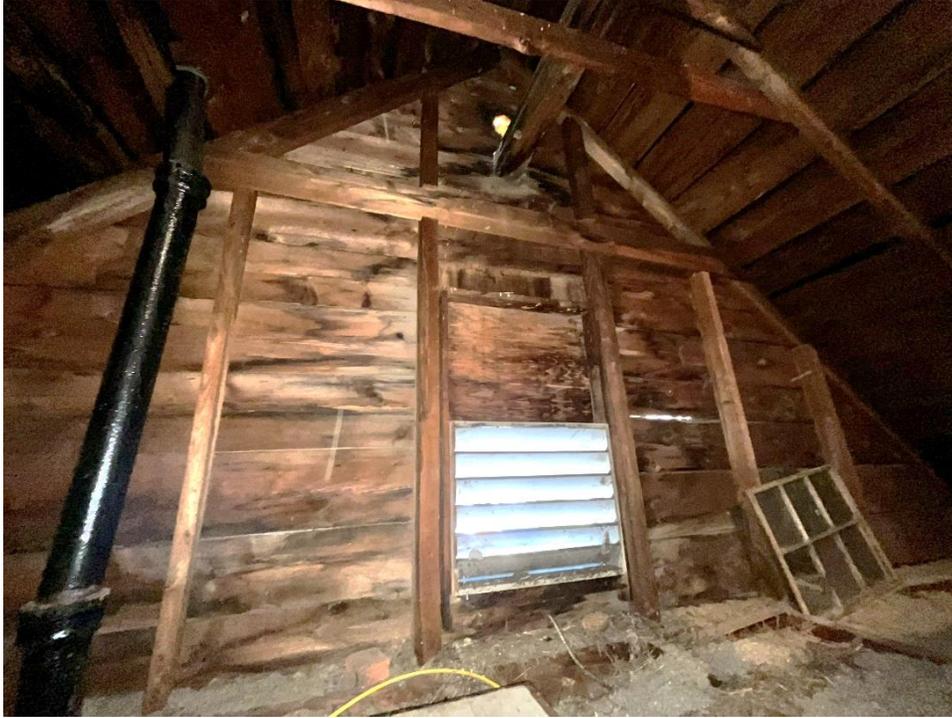
The main attic space is in good condition and shows no water infiltration. The window opening on the west elevation has a louvered vent with an interior screen to allow air circulation, but a smaller vent could be installed beneath the gable to allow air flow and decrease the size of the opening. The sash that was removed is stored next to the window and could be reinstalled.

*Photo 51: Attic interior, west (front) elevation of main building, louvered vent installed in the lower sash opening, with sash stored to the right.*

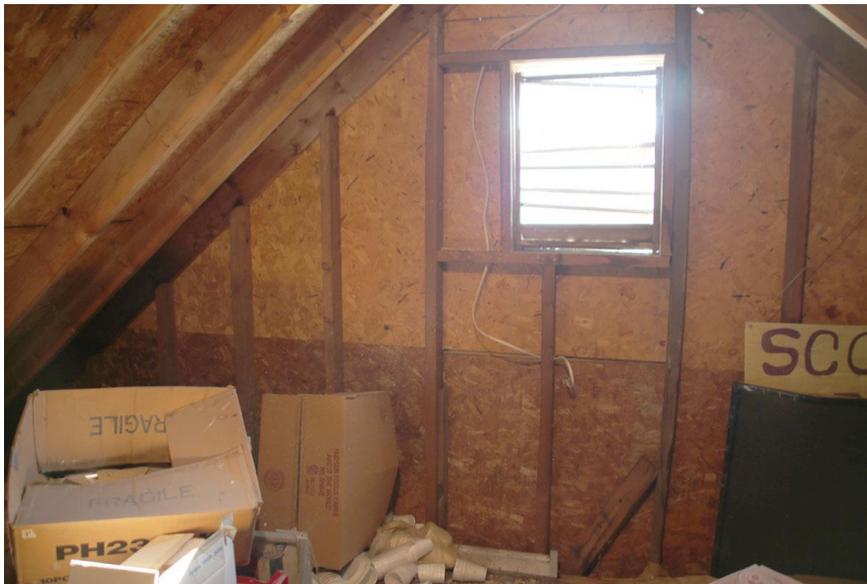
The attic space above the 1984 addition is also generally in good condition, though the connection between the roofline and the earlier building should be reflashed, as gaps between the two structures are apparent from the interior. The eastern wall of the attic also has a louvered vent with an interior screen that is not fitted well to the opening, and the louvers are broken and askew.

*Photo 52: Attic interior, east elevation, rear addition*

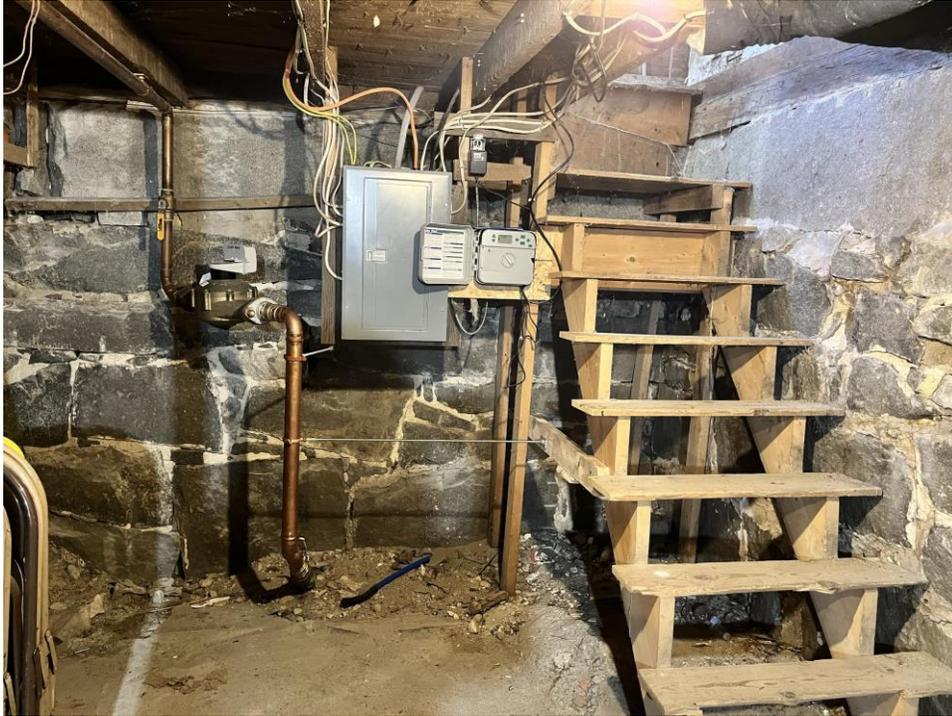
*Photo 55: Northwest corner of the basement, showing the electrical panel and the water meter to the left*

The electrical service serves the main rooms, the addition, attic, and basement. Photos show that the utility drop was re-located after 1972.<sup>37</sup> A single heater is mounted in the large main room on the northeast corner, powered by electricity and fired by two large propane tanks located on the south side of the building, added after 1972. One small horizontal exhaust vent serves this heater without ducting. This aged heater is likely less efficient than a new heat pump or mini-split unit would be, depending on how often the building needs to be in use. There is currently no heat in the office.

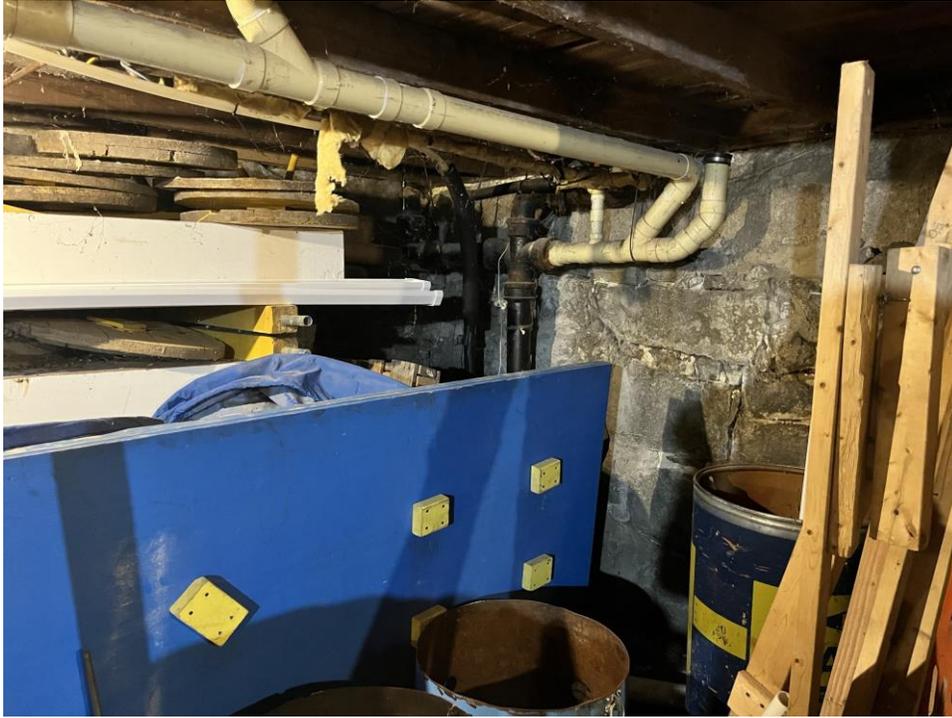
*Photo 56: Plumbing in the basement*

The plumbing is located in the southwest corner of the building, beneath the bathroom. Waste lines from the current bathroom are of modern PVC piping, and the older cast-iron piping and vent still remains beneath the current storage closet, which was formerly a bathroom. The modern plumbing fixtures and toilet in the bathroom are in good, functional condition. The building is on the town's public water and sewer system.
