This is the 14th email update on the Fletcher's Paint Works and Storage Facility Superfund Site in Milford, NH. Excavation work at the Mill Street area was approximately 78% complete as of August 19. During the week ending 8/19, 22 loads of materials were transported to licensed landfill facilities, bringing the Mill Street totals to 451 loads (10,067 tons). The attached figure of the Mill Street area provides an update of the excavation progress.

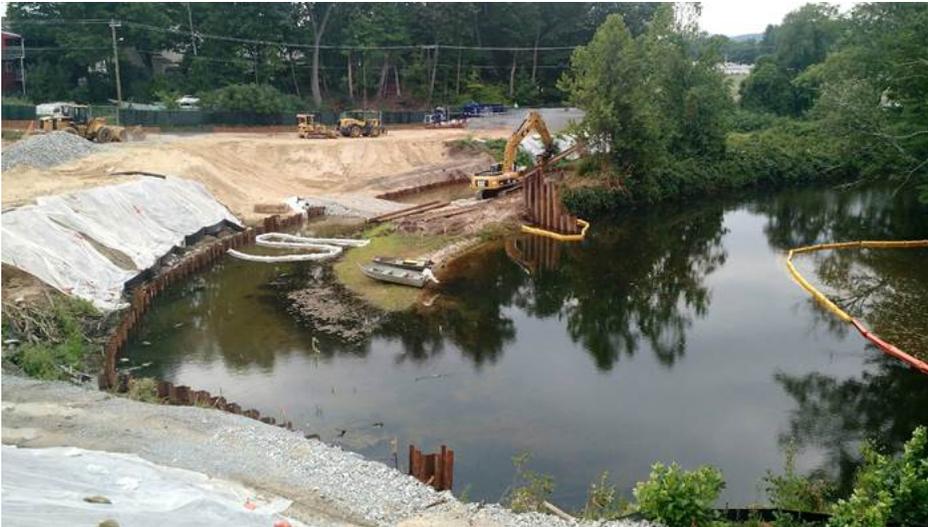
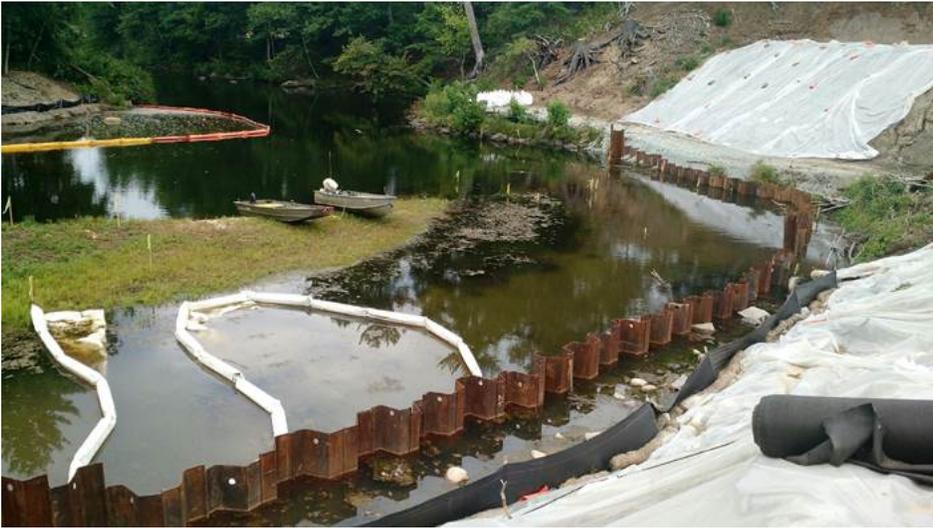
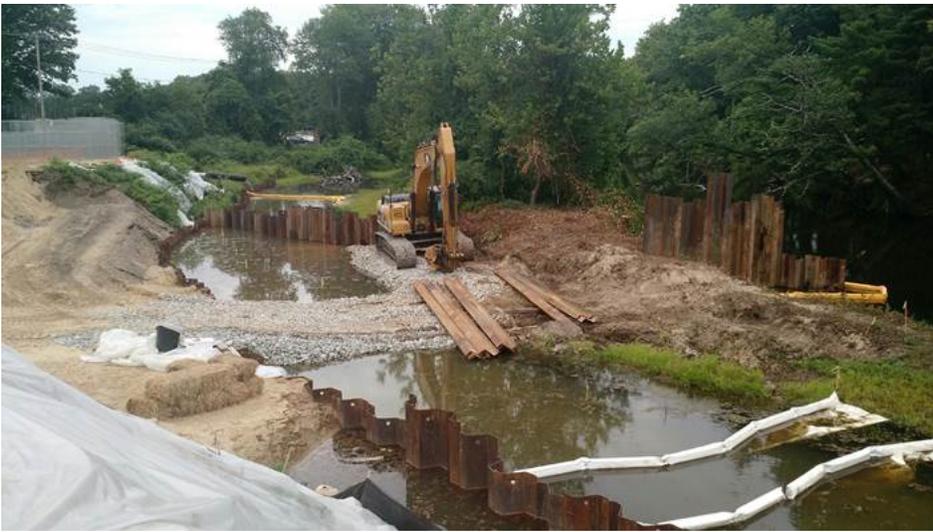
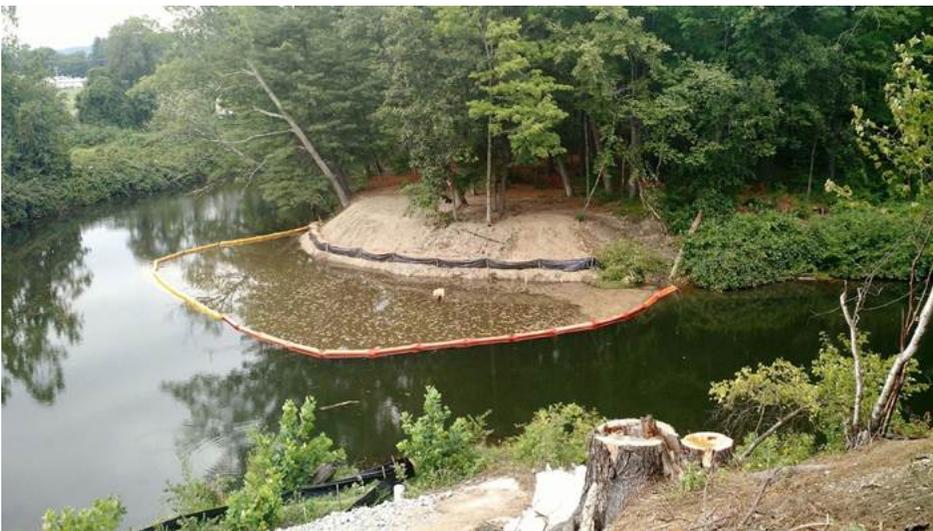
Below are photos from the Fletcher Paint Site this week showing the current status of the Souhegan river activities.

-The grading work on the northern bank was completed this week and GE's contractor installed a silt fence along the bank following completion.

-Sheeting installation was completed in the side and main channel yesterday. The remaining section of sheeting that will be installed across the island is anticipated to be completed today (Friday, 8/26).
