This is the fifth email update on the Fletcher's Paint Works and Storage Facility Superfund Site in Milford, NH. Below is a brief summary of the ongoing work. I have also included a few photos taken this past Tuesday, May 17.

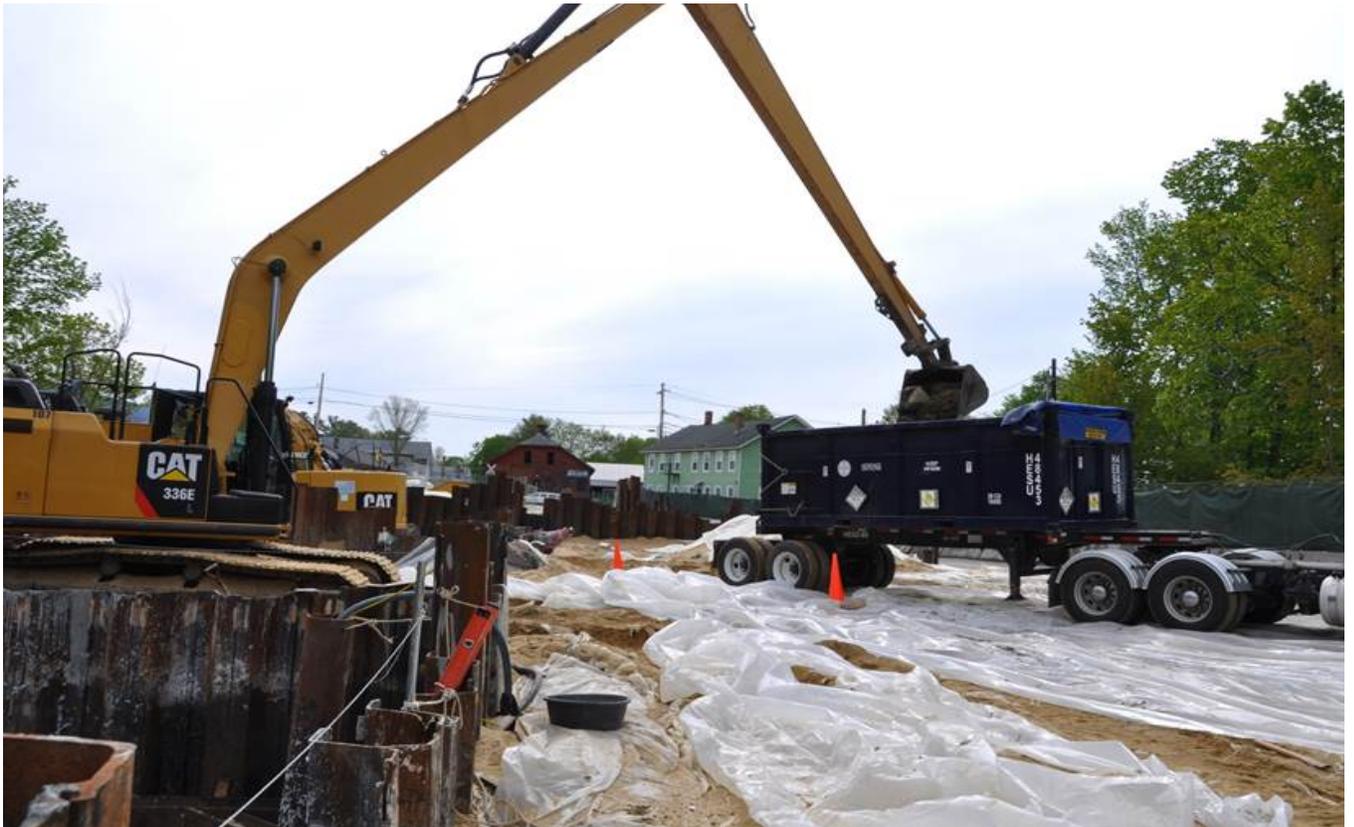
1 Excavated contaminated soil being directly loaded for transport at Mill St.

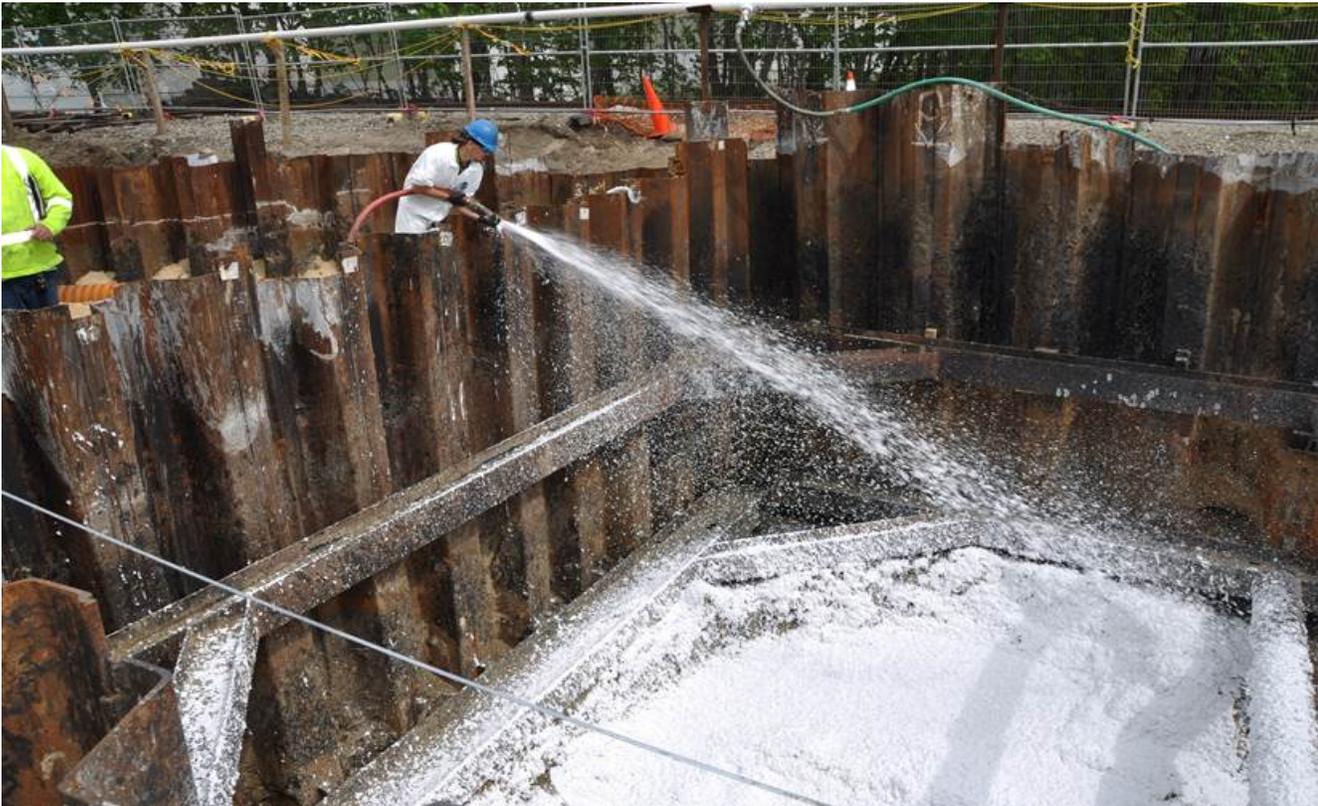
2 Applying vapor suppression foam at Mill St. Note the internal wall bracing in the excavation cell.

- Continued to excavate remaining soils from the first deep cell. Vapor suppression foam was applied to exposed soils within the cell during and following daily excavation, loading, and transport activities. Following the completion of excavation and a confirmation inspection by EPA and NH DES early next week, back filling of the cell is planned.
- Continued dewatering activities within deep excavation cells and continued operation of the water treatment system.
- Maintained soil and poly covers over open excavations.

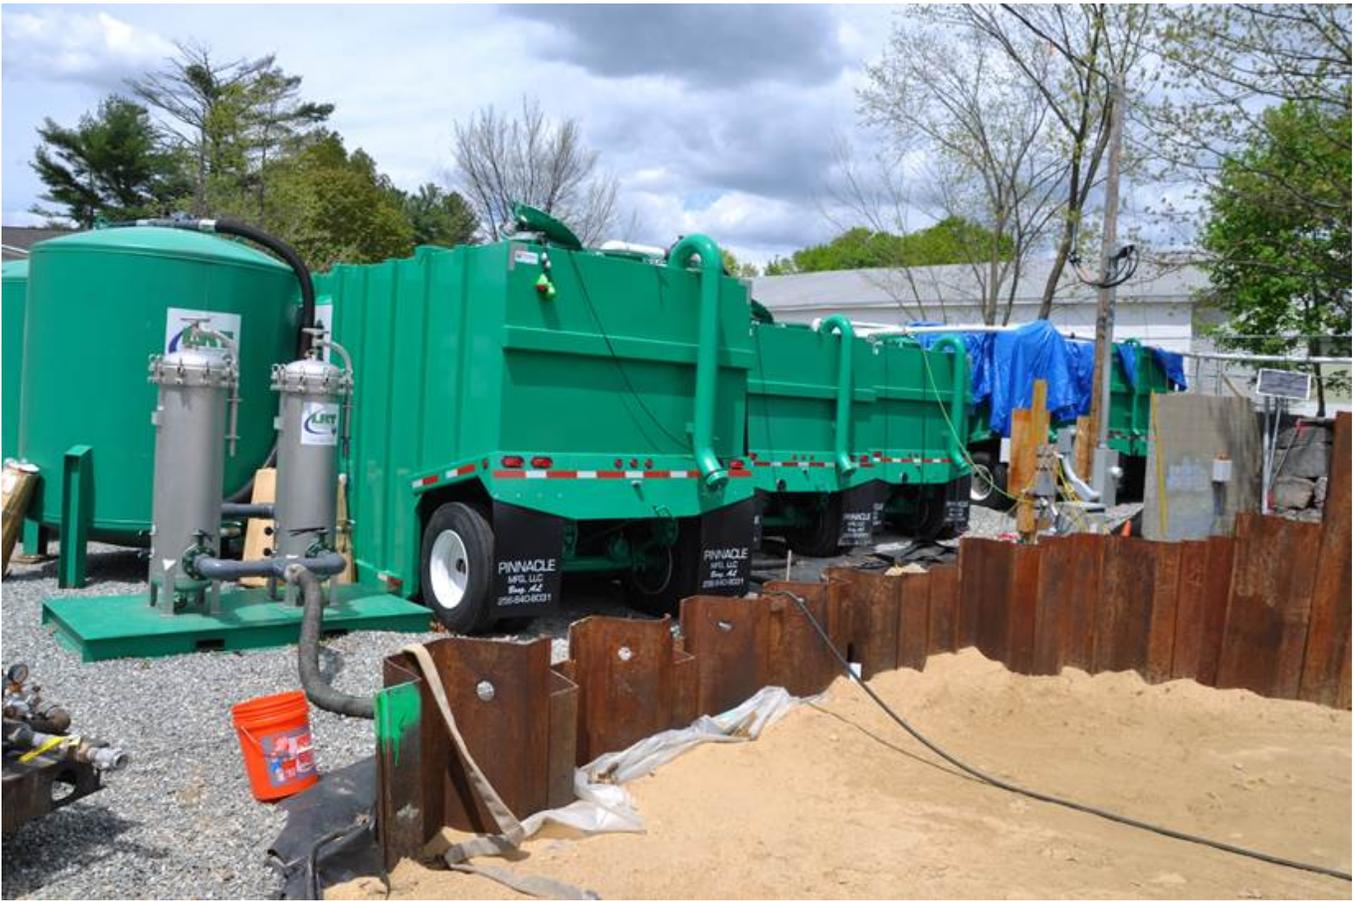
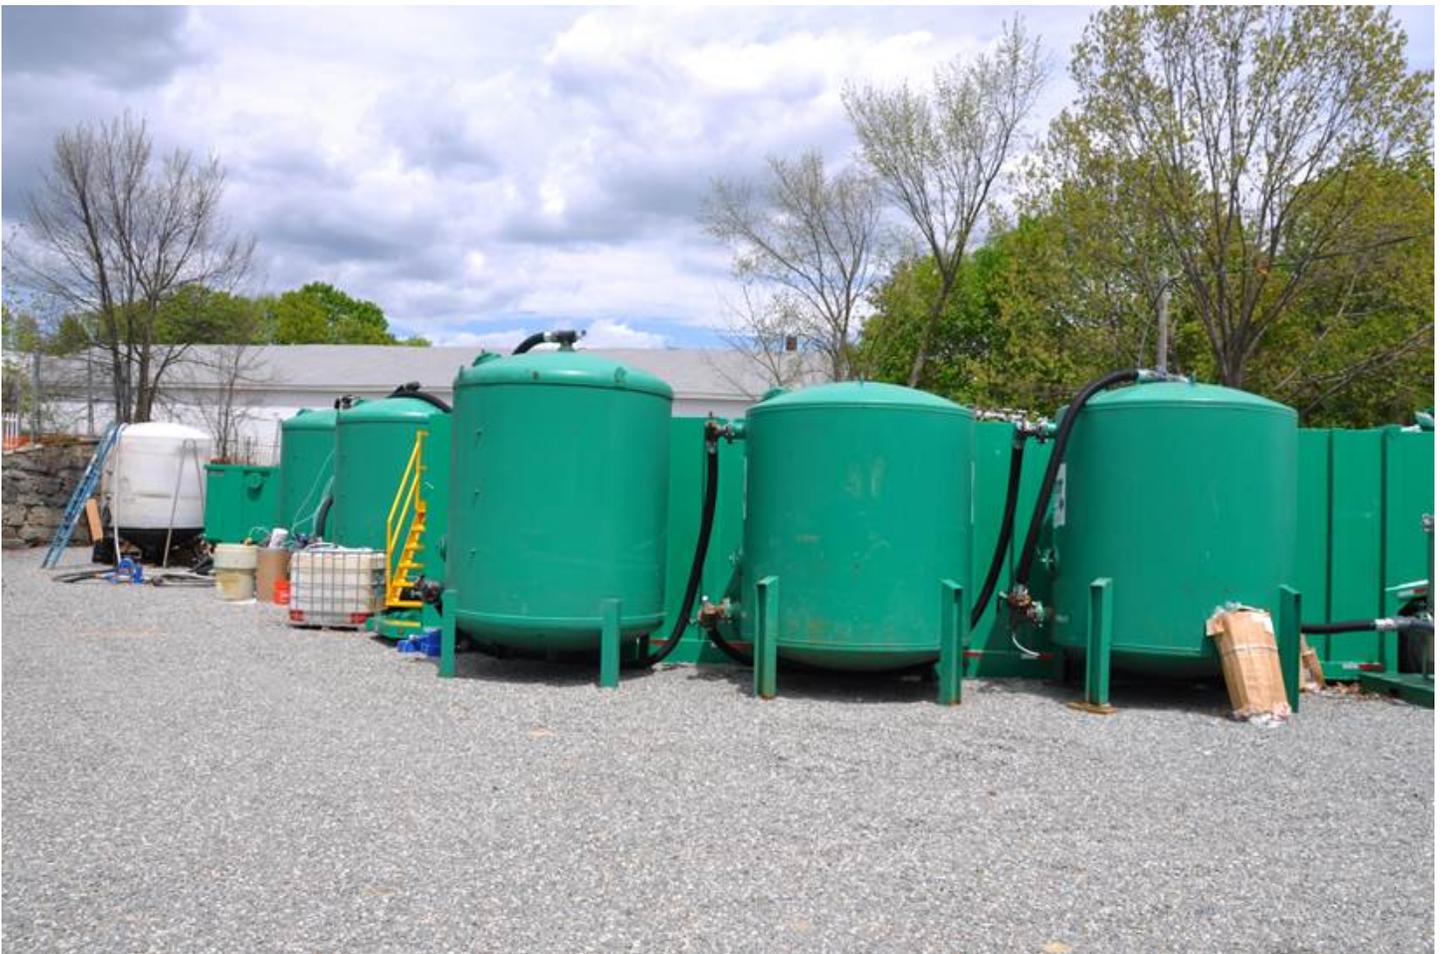
3 & 4 Two views of the temporary water treatment system at Mill St. The deep excavation cells are being continually dewatered to allow for more efficient excavation of soils at the level of the groundwater table

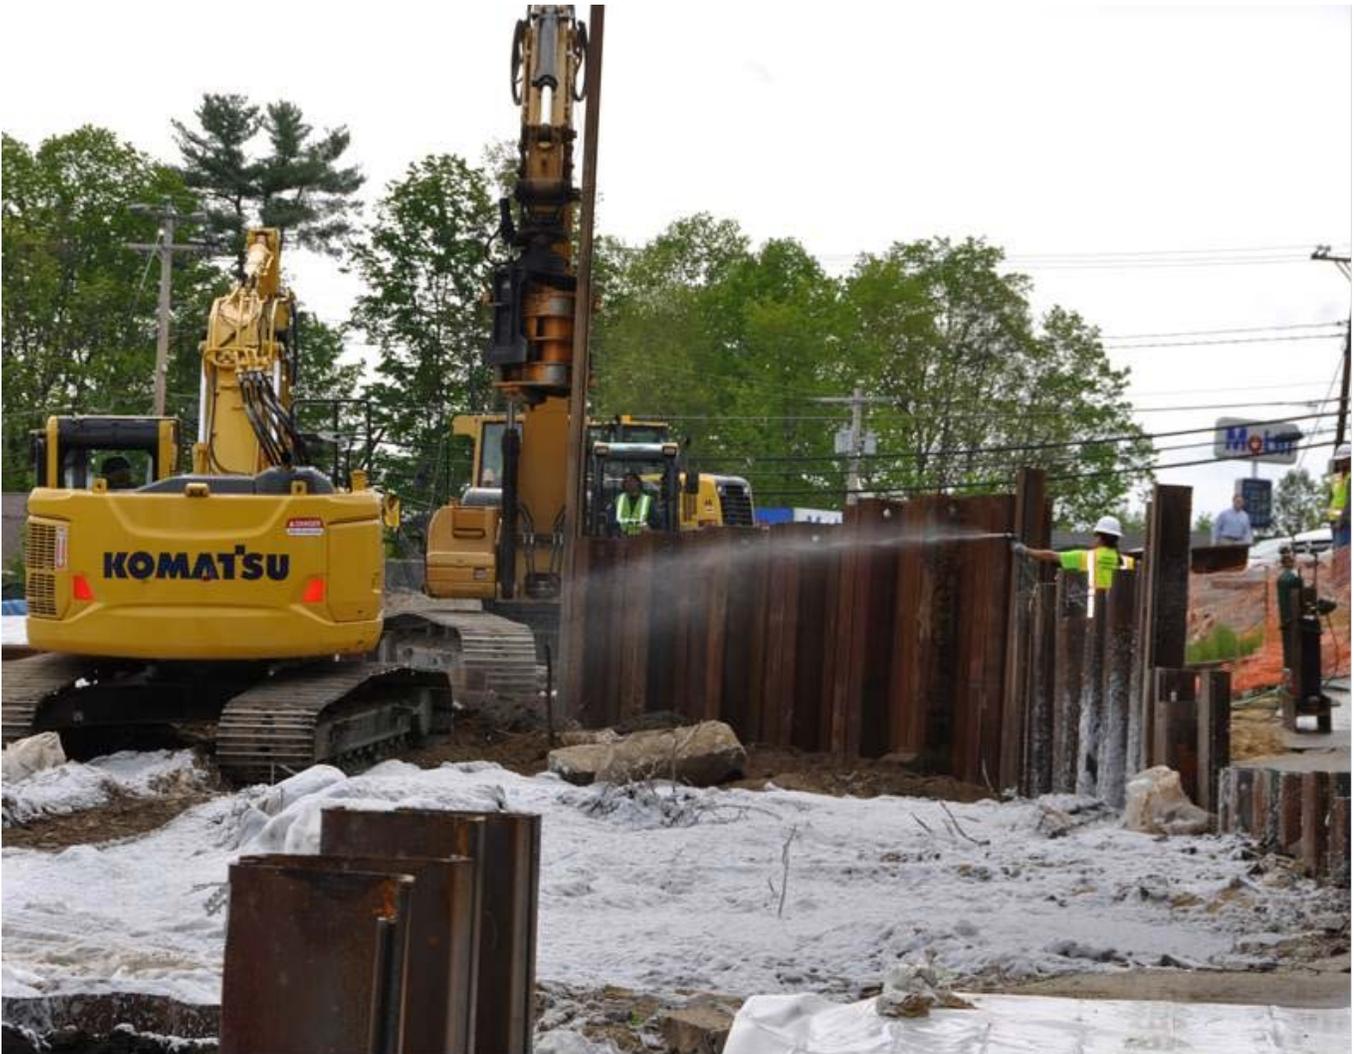
5 Installation of steel sheeting at excavation cells on Elm Street.

- Excavated and direct loaded soils for transport and disposal from several excavation areas.
- Placed clean fill materials activities for selected excavation cells following the receipt of the results of verification soil sampling activities.
- Installed sheeting around several excavation cells.
- Applied additional short-term and long-term vapor suppression foam and maintained poly covers over open excavations and stockpiles.

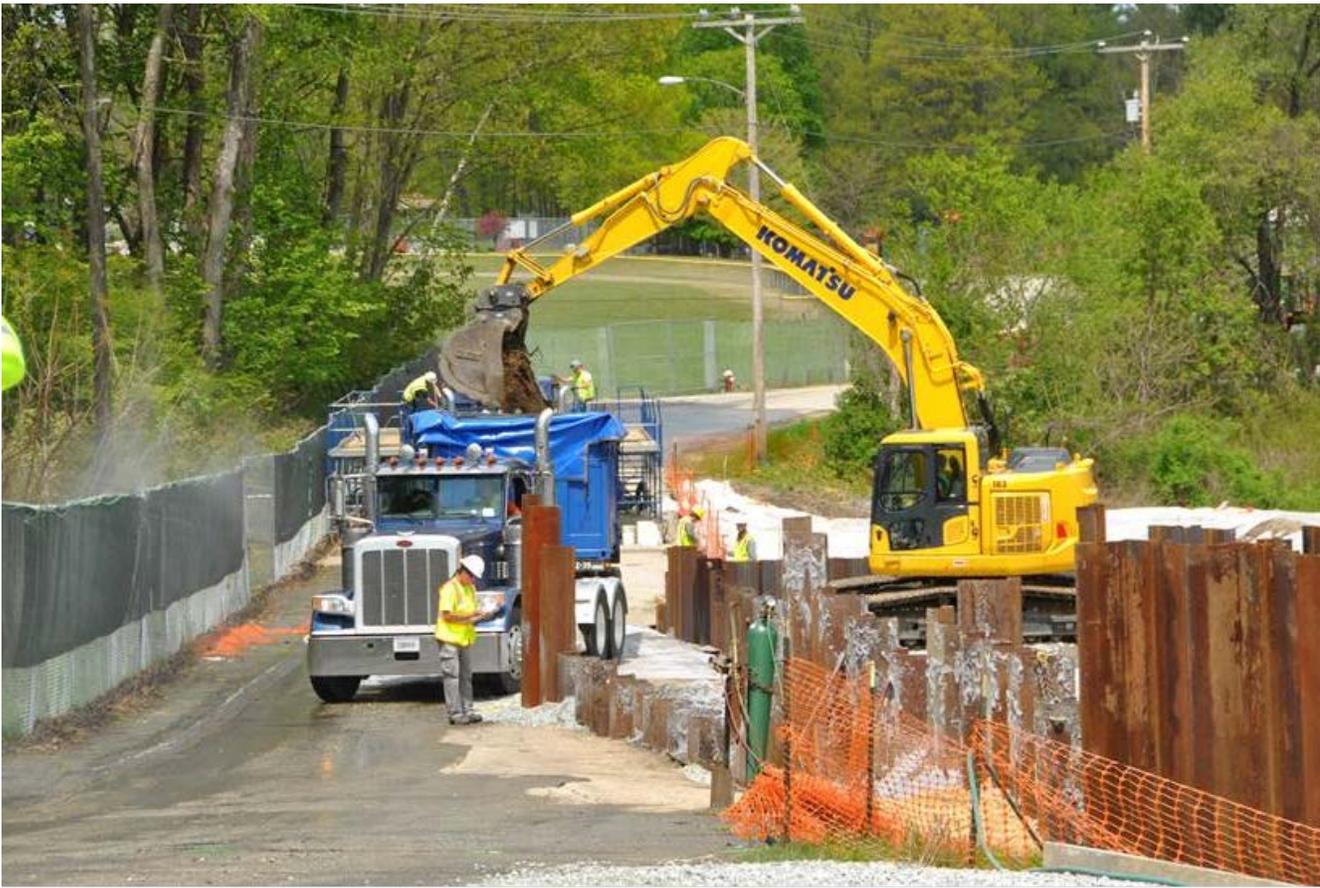
6 Direct loading of excavated soil at Elm St. onto trucks for transport to a licensed disposal facility.
